AIRPROX REPORT No 2017261

Date: 01 Nov 2017 Time: 1608Z Position: 5101N 00115W Location: Southampton CTA/CTR

PART A: SUMMARY OF INFORMATION REPORTED TO UKAB

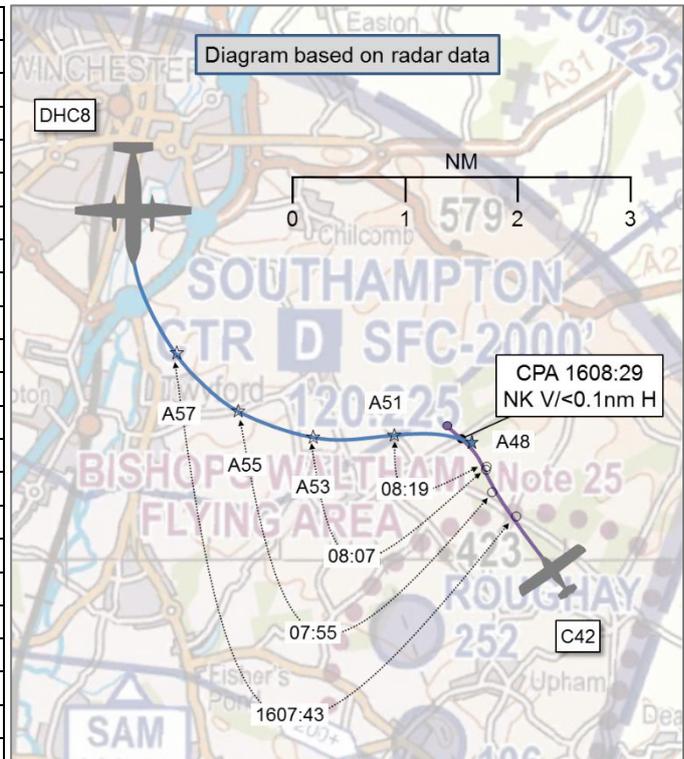
Recorded	Aircraft 1	Aircraft 2
Aircraft	DHC8	C42
Operator	CAT	Civ Pte
Airspace	Solent CTA	NK ¹
Class	D	D
Rules	IFR	VFR
Service	Radar Control	Listening Out
Provider	Solent	Solent
Altitude/FL	5000ft	NK
Transponder	A, C, S	Not fitted
Reported		
Colours	Company	White, green
Lighting	All on	NK
Conditions	VMC	VMC
Visibility	NK	NK
Altitude/FL	4500ft	NK
Altimeter	NK	NK
Heading	080°	NK
Speed	200kt	NK
ACAS/TAS	TCAS II	Not fitted
Alert	None	None
Separation		
Reported	1000ft V/NK H	NK
Recorded	NK V/<0.1nm H

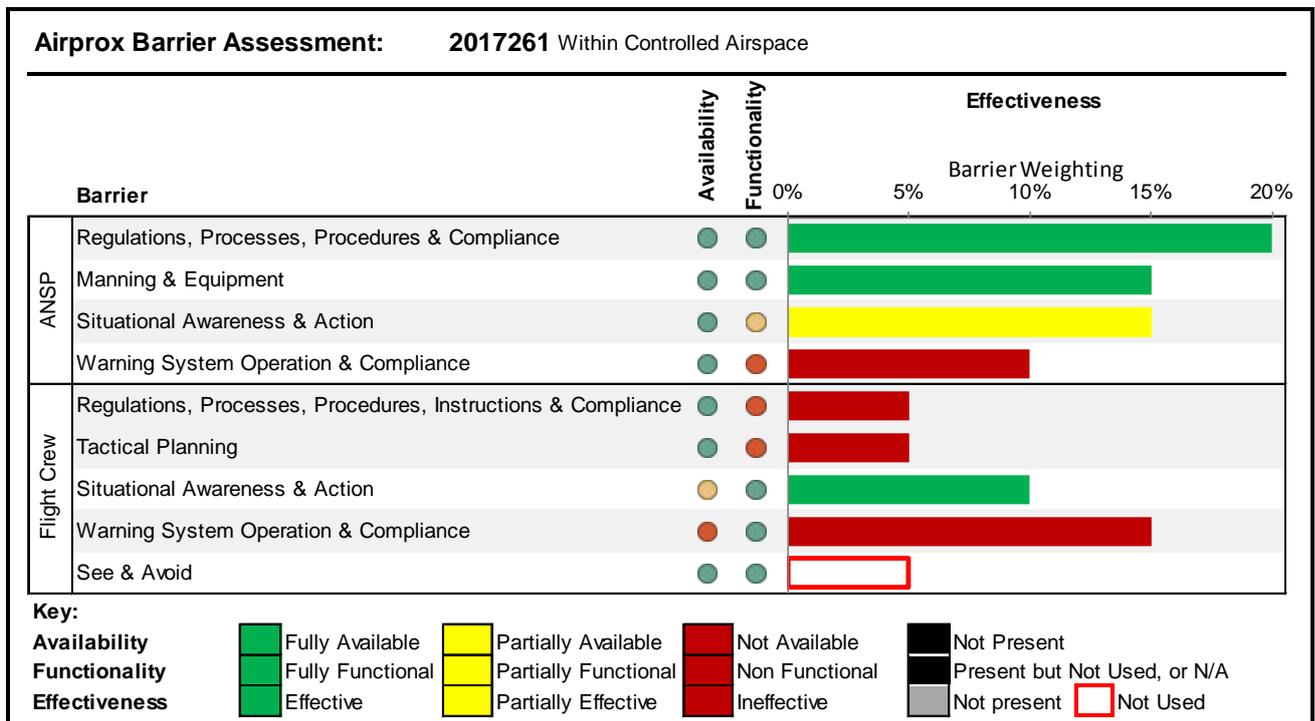
Warning System Operation and Compliance were assessed as **ineffective** because the C42 was not equipped with any systems which were compatible with the DHC8 TCAS II.

See and Avoid were assessed as **not used** because the aircraft were sufficiently separated vertically that the barrier was not employed save for after the aircraft had passed when the DHC8 pilot observed the C42.
