**AIRPROX REPORT No 2017263**

Date: 06 Nov 2017 Time: 1109Z Position: 5234N 00027E Location: 5nm W Marham

**PART A: SUMMARY OF INFORMATION REPORTED TO UKAB**

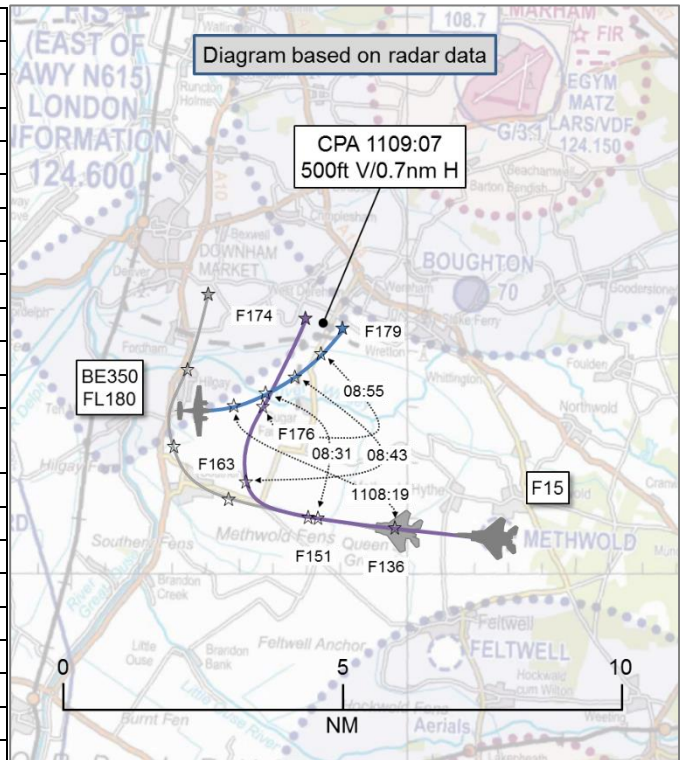
**THE BEECH 350 PILOT** reports that whilst operating in the Marham area for over 2hrs in a 3nm holding pattern at FL180 under the control of Swanwick Mil on VHF, they were requested to re-contact Swanwick on UHF following a controller change. Simultaneously, a pair of F15s that had launched from Lakenheath were observed co-altitude in front of them (as they were turning through a Northerly heading). The F15s then turned and descended approximately 5000ft beneath them before coming back around behind with a high climb-rate causing a TCAS TA quickly followed by a TCAS RA demanding a descent. He recollected that he informed Swanwick Mil on VHF "TCAS RA, standby" whilst the Pilot Handling followed the RA, and reported on a northwest heading. Once clear of conflict, they levelled at FL175 and sighted the F15s to their left, the lead wings-level similar altitude and the wingman left-wing down, still climbing above them, turning to follow the lead. They were advised that the F15s were aware of their position and were holding at FL170 and FL175. He acknowledged and replied they had a contact within 300ft and inside 0.5nm. They then opted to return to the Lincolnshire area to avoid congested airspace. When he reported the RA, the controller sounded pressured and advised him that the F15s were maintaining their cleared levels of FL170 and FL175. With them being at FL180 and not hearing any of the communications from the F15 pilots (all second-hand passed by ATC), they were not aware of the reduced separation of only 500ft.

**THE F15 PILOTS** report that they were in a climb whilst General Handling. They picked up initial radar hits at about 10nm, but had no heading information. They then received an initial traffic call stating that the B350 was tracking west so they adjusted heading to roughly 045°. Shortly afterwards, they received another call that the B350 was actually tracking east. They immediately levelled at FL175 and visually acquired the B350. They passed in front of the B350 by about 2nm, with 500ft vertical separation.

After much discussion, the Board ultimately agreed that the cause of the Airprox was that the F15 pilots had inadvertently flown into conflict with the B350 having not fully assimilated earlier Traffic Information; their being given erroneous Traffic Information in azimuth just prior to CPA, was considered to be only a contributory factor because they had already started their turn towards the B350 before this call had been made. The Board then turned its attention to the risk and noted that, although the B350 and the second F15 had passed close to each other horizontally, they had been separated by 500ft vertically at the time; although the final Traffic Information had been erroneous in azimuth, the Board noted that it had been correct in altitude and that this had caused the F15 pilots to level at FL175, below the B350. For his part, the B350 pilot had received a TCAS TA followed, shortly afterwards, by an RA demanding descent; however, he had only just commenced descent at CPA, and the Board was not convinced that this had materially increased separation due to the dynamics of the encounter. Nevertheless, the

Cause: The F15 pilots inadvertently flew into conflict with the B350 having not fully assimilated earlier Traffic Information.
