AIRPROX REPORT No 2018017

Date: 04 Feb 2018 Time: 1600Z Position: 5117N 00146W Location: Upavon Glider Site

PART A: SUMMARY OF INFORMATION REPORTED TO UKAB

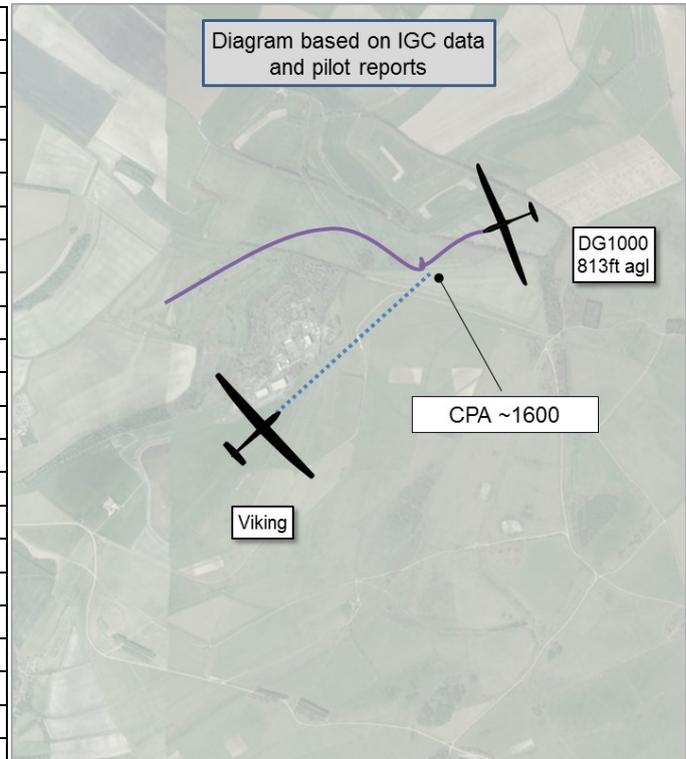
THE VIKING PILOT reports that they launched from RW05. At 1300ft at the top of the climb they selected the glide attitude. They were visual with a DG1000 performing a loop in their 10 o'clock in the direction of the upwind leg of the circuit. The Viking pilot was instructing and started the exercise. During the first element the DG1000 entered a spin, recovering above them and still in their 10 o'clock but drifting downwind. The DG1000 climbed to enter a second spin heading upwind but then turned towards the Viking aircraft. At this stage, the Viking was at 1100ft maintaining runway heading. The DG1000 span towards them, passing their left-wing tip within a distance judged to be approximately 50m. This triggered a rapid, loud, FLARM alert. The DG1000 recovered from the spin beneath them at a possible height of approximately 500 to 600ft AGL, climbed up and turned downwind before landing long on the airfield. They turned back to the airfield, joined the circuit and landed.

THE DG1000 PILOT reports that the Viking pilot raised the issue after the flight. Their opinions differed on the position of where he conducted his spinning practice and the heights involved. DASOR states 500/600 QFE [the Viking pilot's estimate]. His secure FLARM logger file was downloaded and the position of the low point was noted as 1.1km away from the location of the winches at the eastern end of the field, and at a height of 813ft QFE. He had seen the Viking as he was turning away and, in his opinion as a glider pilot, he did not consider there to be a risk of collision. His FLARM did not raise an alarm to that effect.

was to be flown with an extended base leg to join long finals for the hangar on the south side. The DG1000 took off first and headed upwind, the Viking took off shortly afterwards and also headed upwind. Whilst he monitored the operation there were no radio calls heard until the DG1000 pilot and then the Viking pilot called downwind in rapid succession. The Viking landed at the launch point and the aircraft commander approached the tower visibly concerned and relayed to him that an aircraft had just carried out intentional spinning within the area defined as the normal RW05 circuit as they approached the crosswind leg passing their left wing by around 50m lateral separation. The pilot went to talk to the DG1000 pilot and later all three of them reviewed the logger FLARM trace from the DG1000 which showed it spinning just to the east of Trenchard Lines Camp at the area of the crosswind leg of the RW05 circuit. It was stated by the DG1000 crew that they did not see the Viking before or during the spins.
