AIRPROX REPORT No 2018066

Date: 03 May 2018 Time: 1358Z Position: 5104N 00036W Location: 3.5nm SW Dunsfold

PART A: SUMMARY OF INFORMATION REPORTED TO UKAB

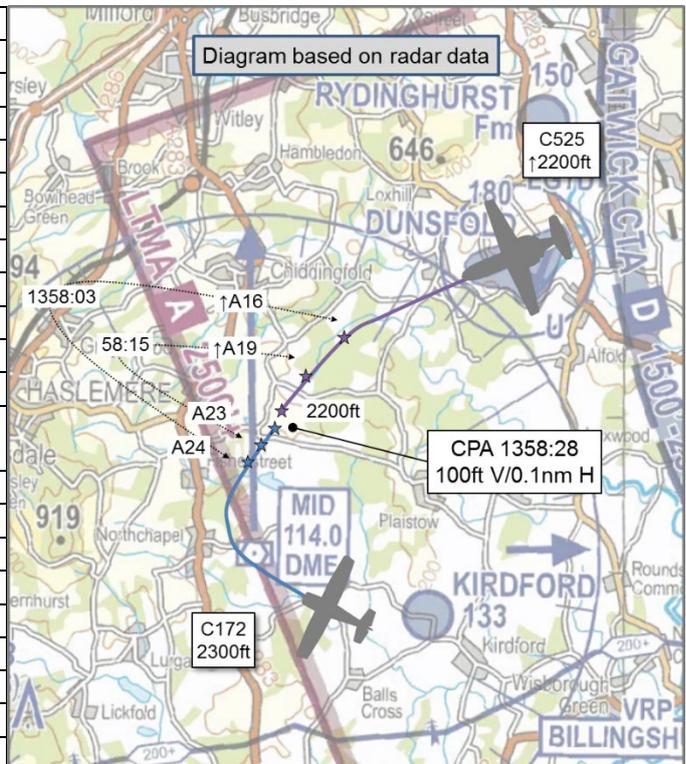
Recorded	Aircraft 1	Aircraft 2
Aircraft	C172	C525
Operator	Civ Pte	Civ Exec
Airspace	London FIR	London FIR
Class	G	G
Rules	VFR	VFR
Service	Basic	Basic ¹
Provider	Farnborough	Farnborough
Altitude/FL	2300ft	2200ft
Transponder	A, C	A, C, S
Reported		
Colours	White, Blue	White, Blue
Lighting	Strobes, Nav, LED landing	Strobes, Nav, Beacon
Conditions	VMC	VMC
Visibility	>20km	>10km
Altitude/FL	2300ft	2000ft
Altimeter	QNH (1019hPa)	QNH (1019hPa)
Heading	024°	260°
Speed	110kt	160kt
ACAS/TAS	Not fitted	TCAS I
Alert	N/A	TA
Separation		
Reported	10ft V/300-400ft H	100ft V/700- 1000m H
Recorded	100ft V/<0.1nm H
