AIRPROX REPORT No 2018103

Date: 01 Jun 2018 Time: 0959Z Position: 5121N 00048W Location: 6nm N Farnborough

PART A: SUMMARY OF INFORMATION REPORTED TO UKAB

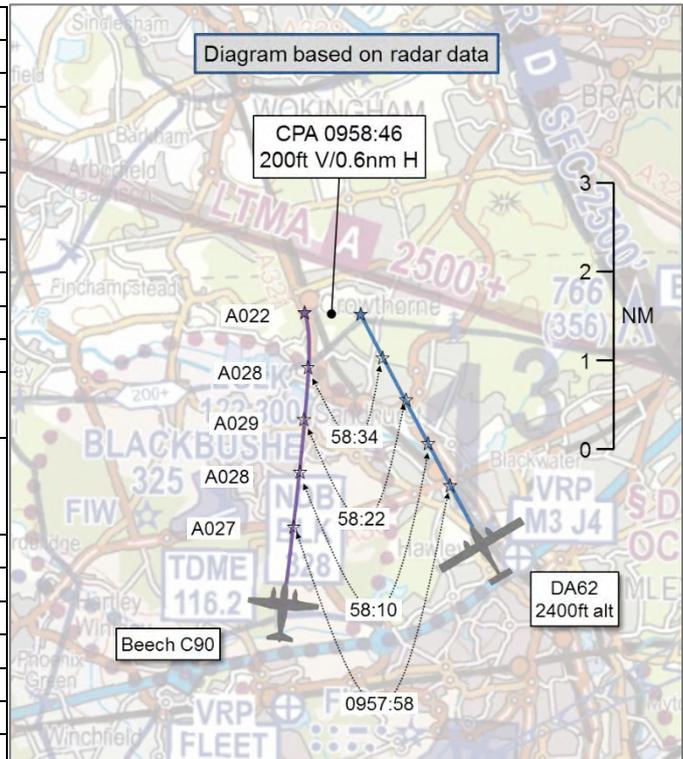
Recorded	Aircraft 1	Aircraft 2
Aircraft	DA62	BE90
Operator	Civ Comm	Civ FW
Airspace	London FIR	London FIR
Class	G	G
Rules	IFR	IFR
Service	Traffic	Traffic
Provider	Farnborough	Farnborough
Altitude/FL	2200ft	2400ft
Transponder	A,C,S	A,C,S
Reported		
Colours	Mainly white	White with black/red stripes
Lighting	Strobes, position,	Strobes, nav, recognition, beacon
Conditions	IMC	IMC
Altitude/FL	2400ft	3400ft ↓ 2000ft
Altimeter	QNH (1018hPa)	QNH
Heading	350°	North
Speed	155kt	200kt
ACAS/TAS	TAS	TCAS I
Alert	TA	TA
Separation		
Reported	Not seen	Not seen
Recorded	200ft V/0.6nm H
