## AIRPROX REPORT No 2018142

Date: 22 Jun 2018 Time: 1135Z Position: 5132N 00303W Location: Thirlmere

### PART A: SUMMARY OF INFORMATION REPORTED TO UKAB

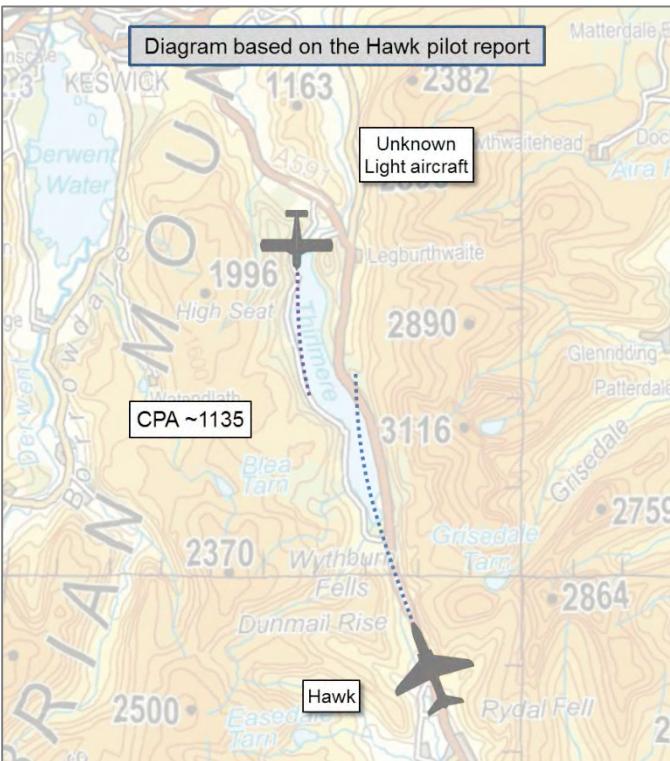
**THE HAWK PILOT** reports conducting a low level training sortie, routing northbound along the Windermere to Keswick low-level flow system, when a Merlin helicopter pilot, to the north of his position, transmitted details of a light-aircraft routing southbound along Lake Thirlmere, 'against the [military] flow system'. The Hawk pilot saw a TCAS contact at a range of 5nm, which appeared to match the reported position of the other aircraft, and he gained visual contact at 3nm. He made a gentle right turn to remain on the right-hand side of the valley and the other aircraft passed down his left, slightly below.
