## AIRPROX REPORT No 2018147

Date: 23 Jun 2018 Time: 1146Z Position: 5147N 00107E Location: Clacton airfield

### PART A: SUMMARY OF INFORMATION REPORTED TO UKAB

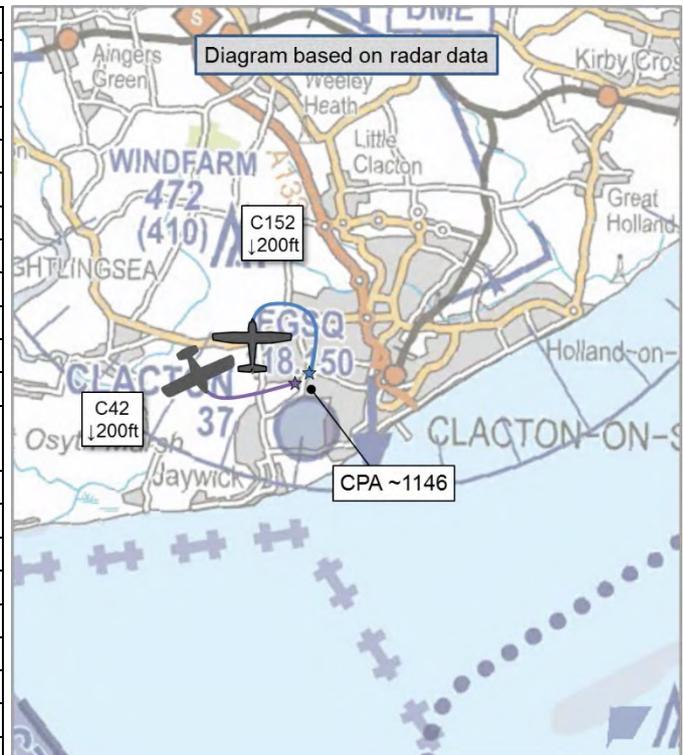
**THE C152 PILOT** reports that he was flying into Clacton with PPR and had received the airfield brief. He switched from Southend Radar to Clacton Radio and flew east to the coast to join downwind for RW18 at 1000ft. He called inbound and then made the usual 'downwind' and 'turning base' calls before slowing the aircraft down to turn final at 500ft and called 'final'. Just as he was flaring to touch down, an aircraft flew about 10ft above to land ahead, luckily the other pilot decided to go around because he was too long on approach before the pedestrian pathway. He noted that he had not heard any positioning calls from the other pilot, other than the go-around call. Once on the ground he spoke to the pilot who confirmed that he had not seen the C152, but went around because he was landing long.

**THE C42 PILOT** reports that as he approached the Clacton circuit he saw the Cessna heading north at about 1000ft. He believed he heard a call that he was leaving the circuit, and certainly did not hear any other circuits calls, so he discounted him as circuit traffic. He joined for a short circuit, calling that he was joining 'right base' on the RT. The shortened circuit was to avoid flying low over the houses on the standard approach because the C42 doesn't lose height very well without a decent headwind and RW18 at Clacton is a downhill runway which causes less speed bleeding and increased ground effect. As he joined the circuit he did not see any traffic on final, but the other plane may have been under his nose, or hidden by the ground clutter of the housing estate. He was unable to lose height and speed sufficiently so declared going around and, after climbing out, heard the Cessna pilot ask where he had come from. At no point prior did he have visual contact with the C152. After the second landing attempt he met the airfield operator and the other pilot and was informed that he had flown over the C152 by only a few feet. Although neither pilot had heard the others' calls, the airfield operator confirmed that the correct calls had been made.
