**AIRPROX REPORT No 2018158**

Date: 29 Jun 2018 Time: 1502Z Position: 5325N 00312W Location: 5nm NW Liverpool Airport

**PART A: SUMMARY OF INFORMATION REPORTED TO UKAB**

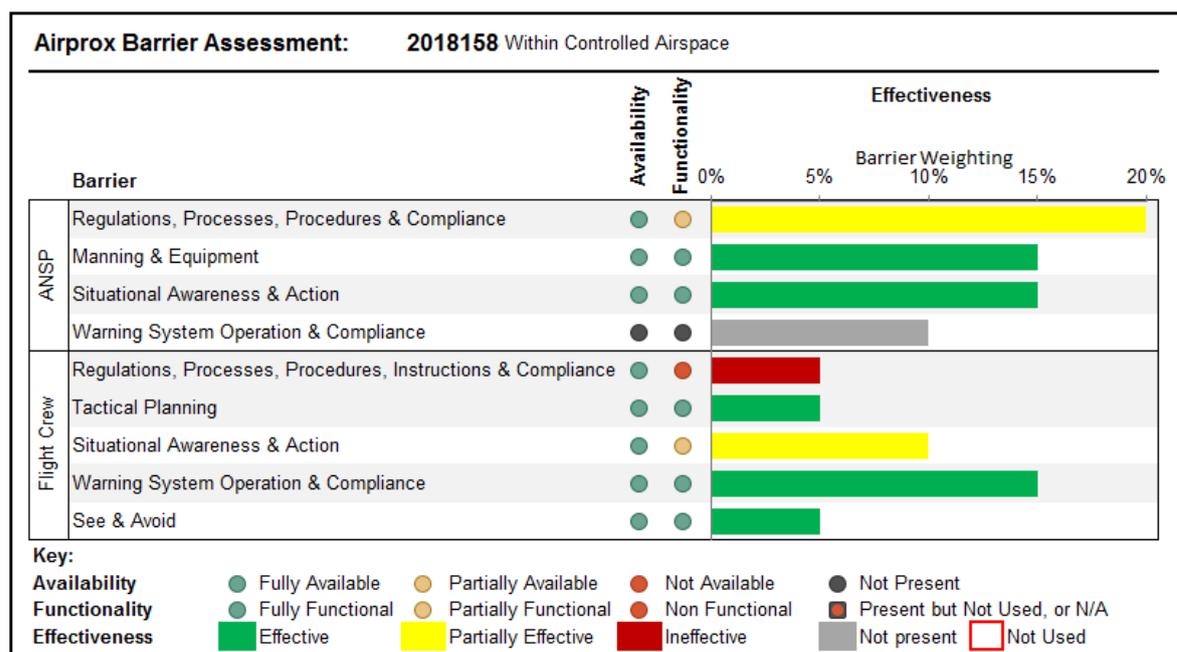
**Regulations, Processes, Procedures, Instructions and Compliance** were assessed as **ineffective** because the A319 crew started to turn right before contacting ATC to resolve their confusion about the heading issued.

**Situational Awareness and Action** were assessed as **partially effective** because the A319's TCAS display would likely have shown the position of the A320 as proximate traffic, information which the A319 crew could have used to their advantage before turning.
