AIRPROX REPORT No 2018185

Date: 25 Jul 2018 Time: 1220Z Position: 5239N 00009E Location: 1NM south of Wisbech

PART A: SUMMARY OF INFORMATION REPORTED TO UKAB

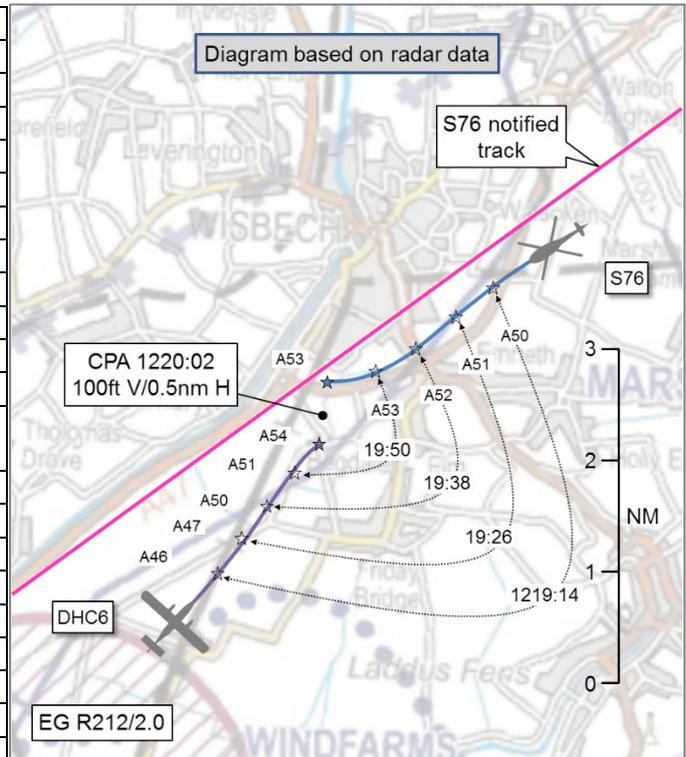
Recorded	Aircraft 1	Aircraft 2
Aircraft	S76	DHC6
Operator	Civ Helo	Civ FW
Airspace	London FIR	London FIR
Class	G	G
Rules	IFR	VFR
Service	Traffic	AGCS
Provider	Marham	Chatteris
Altitude/FL	5300ft	5400ft
Transponder	A, C, S	A, C, S
Reported		
Colours	Maroon	Purple, silver
Lighting	Strobes, HISL, nav	Beacon
Conditions	VMC	VMC
Visibility	>10km	20km
Altitude/FL	5400ft	FL050
Altimeter	QNH (1015hPa)	SPS
Heading	236°	010°
Speed	130kt	100kt
ACAS/TAS	TCAS I	Not fitted
Alert	TA	N/A
Separation		
Reported	0ft V/0.5nm H	0ft V/0.5nm H
Recorded	100ft V/0.5nm H
