AIRPROX REPORT No 2018186

Date: 27 Jun 2018 Time: 1510Z Position: 5257N 00033W Location: Barkston Heath

PART A: SUMMARY OF INFORMATION REPORTED TO UKAB

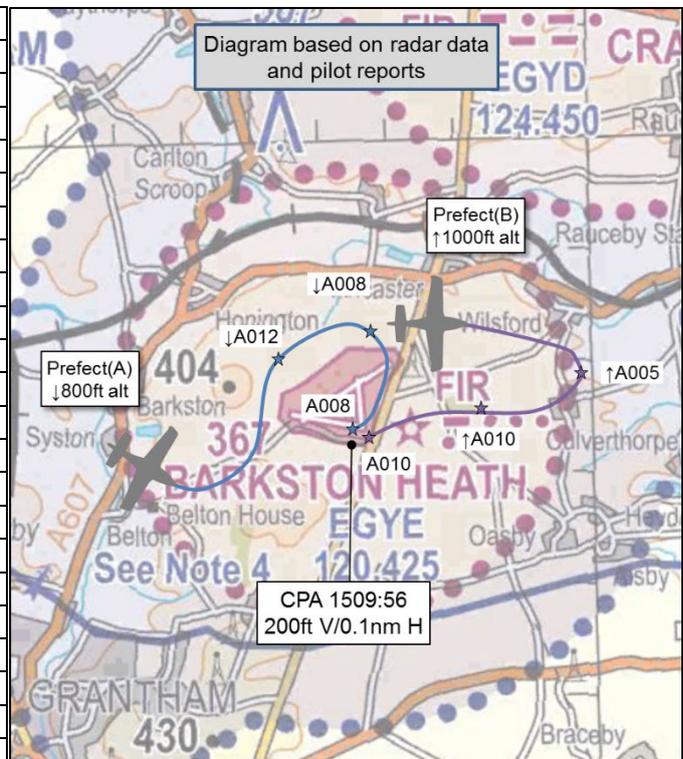
Recorded	Aircraft 1	Aircraft 2
Aircraft	Prefect(A)	Prefect(B)
Operator	HQ Air (Trg)	HQ Air (Trg)
Airspace	Barkston ATZ	Barkston ATZ
Class	G	G
Rules	VFR	VFR
Service	ACS	ACS
Provider	Barkston	Barkston
Altitude/FL		
Transponder	A, C, S	A, C, S
Reported		
Colours	White, Blue	White
Lighting	NK	NK
Conditions	VMC	VMC
Visibility	10km	NK
Altitude/FL	800ft	1000ft
Altimeter	QFE	QFE
Heading	240°	240°
Speed	110kt	120kt
ACAS/TAS	TAS	TAS
Alert	TA	TA
Separation		
Reported	200ft V/200m H	200ft V/200ft H
Recorded	200ft V/0.1nm H
