AIRPROX REPORT No 2018217

Date: 15 Aug 2019 Time: 1514Z Position: 5121N 00103W Location: 3nm N Basingstoke

PART A: SUMMARY OF INFORMATION REPORTED TO UKAB

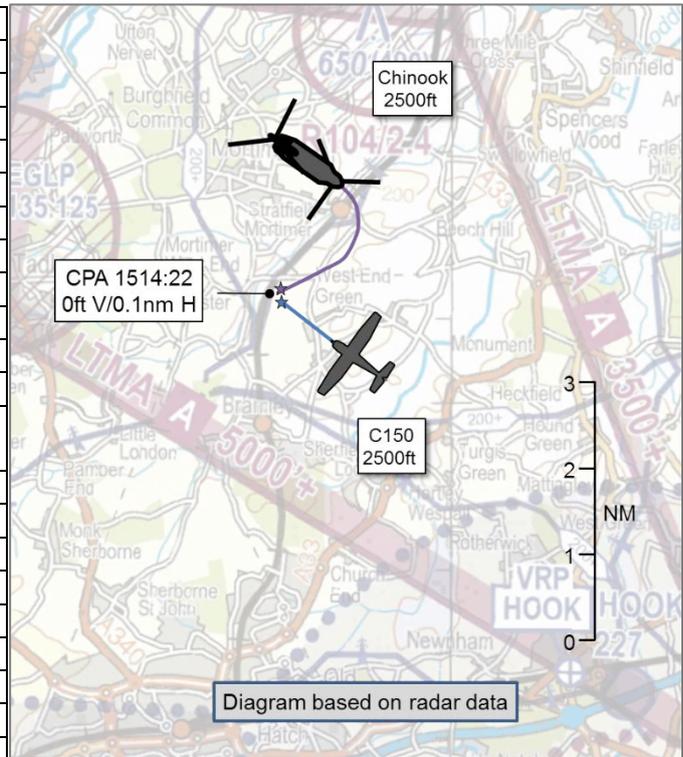
Recorded	Aircraft 1	Aircraft 2
Aircraft	C150	Chinook
Operator	Civ FW	HQ JHC
Airspace	London FIR	London FIR
Class	G	G
Rules	VFR	VFR
Service	Listening Out	Traffic
Provider	Farnborough	Odiham
Altitude/FL	2500ft	2500ft
Transponder	A, C, S	A, C, S
Reported		
Colours	White, Red	Green
Lighting	Beacon, Nav, Landing	Nav, HISLs,
Conditions	VMC	VMC
Visibility	40nm	NR
Altitude/FL	2700ft	2500ft
Altimeter	QNH (1017hPa)	QNH
Heading	250°	270°
Speed	80kt	NK
ACAS/TAS	Not fitted	TAS
Alert	N/A	Information
Separation		
Reported	10ft V/20m H	300ft V/500m H
Recorded	0ft V/0.1nm H
