**AIRPROX REPORT No 2018229**

Date: 20 Aug 2018 Time: 1338Z Position: 5155N 00153W Location: 11nm E Gloucester airport

**PART A: SUMMARY OF INFORMATION REPORTED TO UKAB**

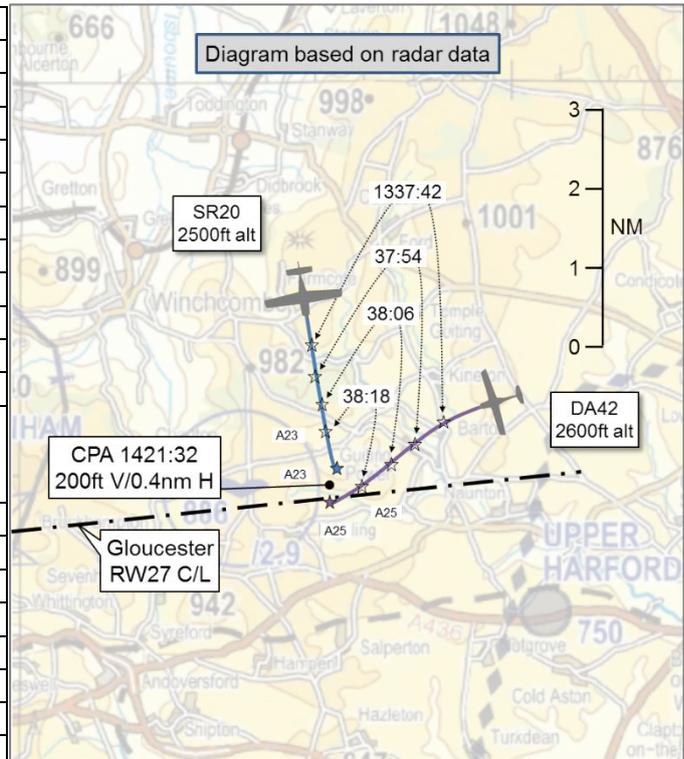
Recorded	Aircraft 1	Aircraft 2
Aircraft	SR20	DA42
Operator	Civ FW	Civ FW
Airspace	London FIR	London FIR
Class	G	G
Rules	IFR	VFR
Service	Procedural	None <sup>1</sup>
Provider	Gloster	(Gloster)
Altitude/FL	FL21	FL23
Transponder	A,C,S	A,C,S
Reported		
Colours	NK	White
Lighting	NK	Strobes, nav, landing, taxi, position
Conditions	VMC	VMC
Visibility	NK	10km
Altitude/FL	2500ft	2000ft
Altimeter	QNH	QNH
Heading	NK	270°
Speed	NK	120kt
ACAS/TAS	TAS	TAS
Alert	Information	'TA'
Separation		
Reported	400ft V/200m H	NK V/1nm H
Recorded	200ft V/0.4nm H

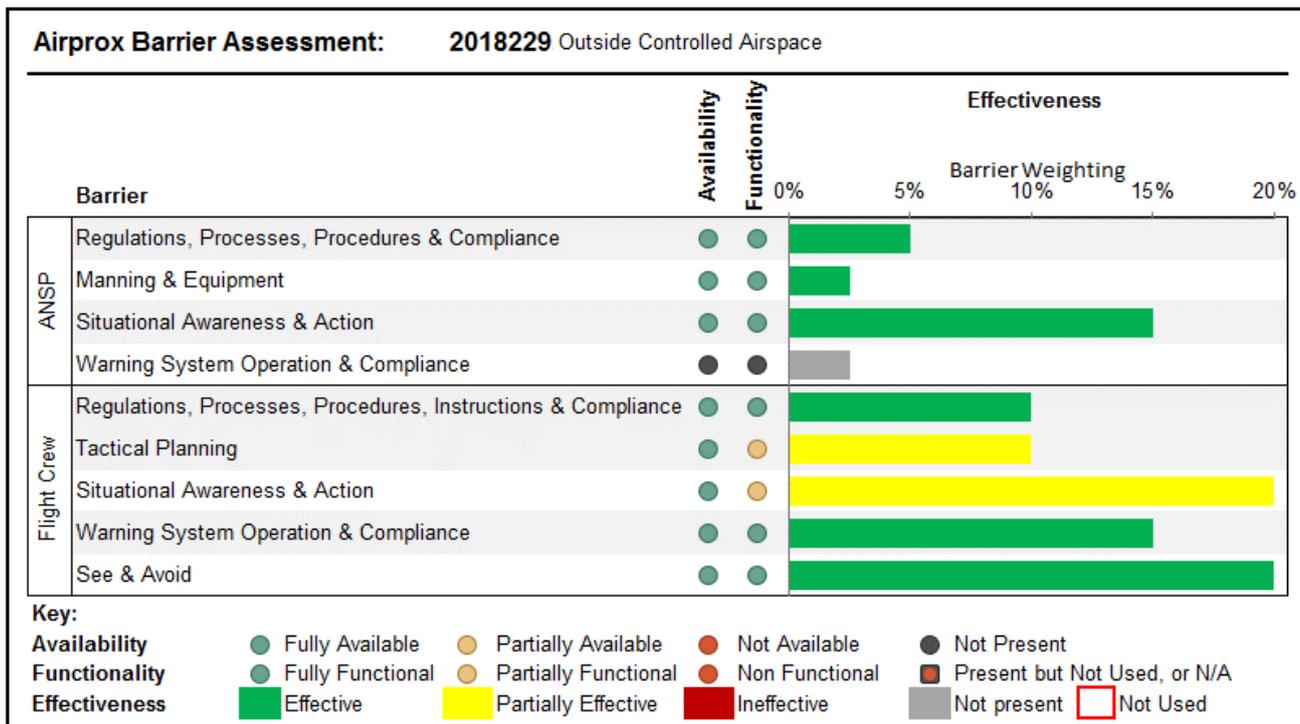
**Situational Awareness and Action** were assessed as **partially effective** because, although the DA42 pilot had received a warning from his TAS of the presence of the SR20 at 1-2nm ahead, he did not act sufficiently on this information to avoid the aircraft by a more suitable margin.
