AIRPROX REPORT No 2018248

Date: 05 Sep 2018 Time: 1429Z Position: 5302N 00050W Location: 5nm east Syerston

PART A: SUMMARY OF INFORMATION REPORTED TO UKAB

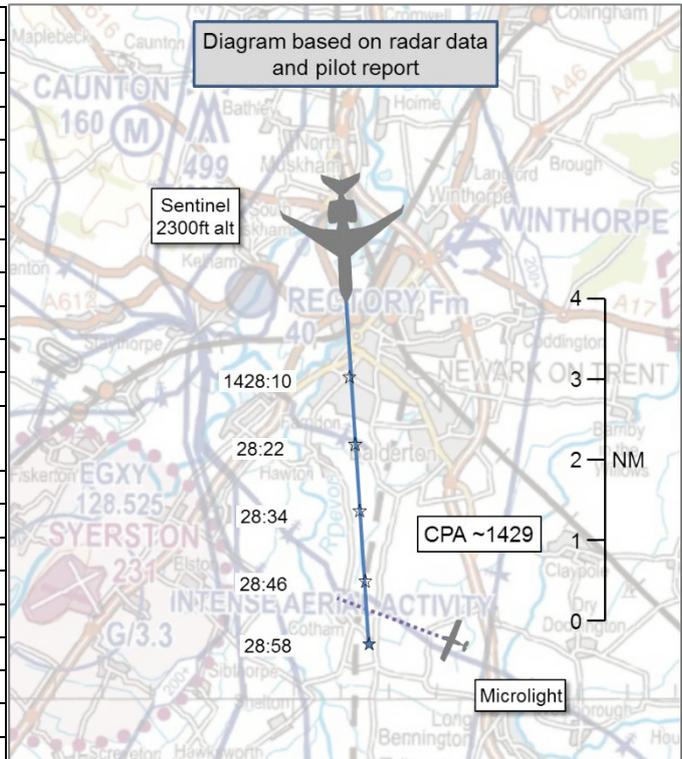
THE SENTINEL PILOT reports being in receipt of radar vectors for the PAR to Waddington RW02. The aircraft was flying ‘in and out of cloud’ when the flight-deck crew observed a yellow, green and red microlight pass underneath. There was insufficient time to take avoiding action. ATC were immediately informed, having not previously reported a contact in the vicinity. No TCAS contact was observed by the crew prior to the incident. On a subsequent instrument circuit ATC had a ‘weak contact’ in the same area as the Airprox and vectored the aircraft to avoid.

He assessed the risk of collision as ‘High’.
