AIRPROX REPORT No 2018255

Date: 13 Sep 2018 Time: 1042Z Position: 5204N 00031E Location: 1nm NW Ridgewell Gliding Site.

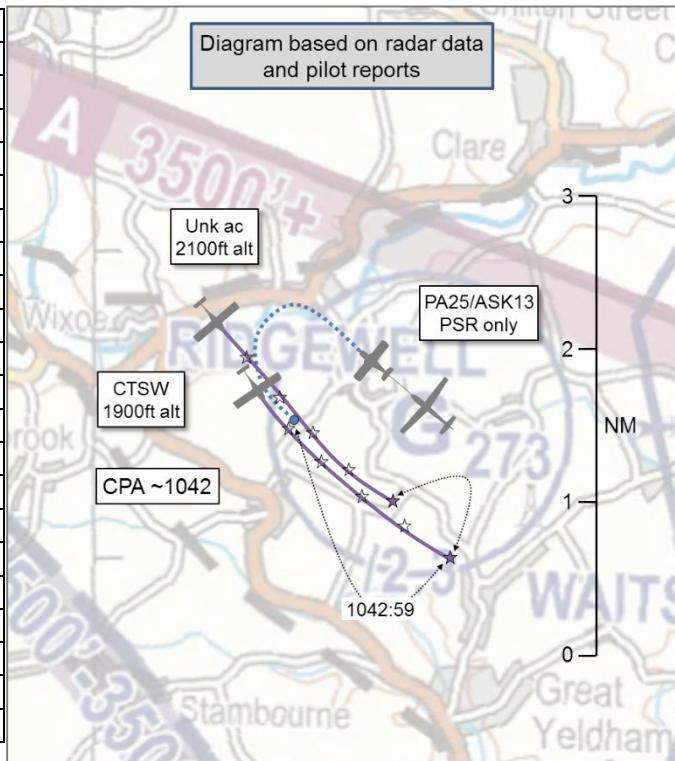
THE PIPER PA25 PAWNEE PILOT reports that he was in the climb towing a ASK13 glider. Two aircraft passed him close by. The first light-aircraft passed very close in front of him, which was the first time that he had seen it and a second, at a similar distance, 1 minute afterwards. The pilot's diagram shows the first aircraft, the CTSW, overtaking him on the right and then flying in front across his track. The second overtook him on his left-side. [It has not been possible to identify the second aircraft.]
