AIRPROX REPORT No 2018302

Date: 14 Nov 2018 Time: 1146Z Position: 5138N 00131W Location: Stanford in the Vale

PART A: SUMMARY OF INFORMATION REPORTED TO UKAB

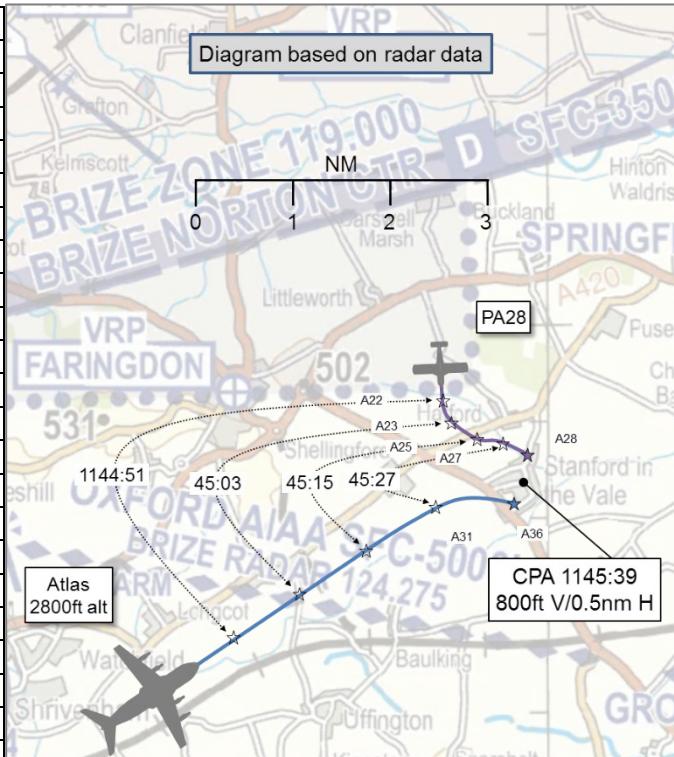
Recorded	Aircraft 1	Aircraft 2
Aircraft	Atlas/A400	PA28
Operator	HQ Air (Ops)	Civ FW
Airspace	London FIR	London FIR
Class	G	G
Rules	VFR	VFR
Service	Traffic	Basic
Provider	Brize Director ¹	Brize Zone ¹
Altitude/FL	3600ft	2800ft
Transponder	A, C, S	A, C
Reported		
Colours	Grey	White, orange
Lighting	Landing/nav/HISL	Anti-col, nav
Conditions	VMC	VMC
Visibility	10km	10km
Altitude/FL	2800ft	3000ft
Altimeter	NK	QNH (NK hPa)
Heading	360°	150°
Speed	210kt	80kt
ACAS/TAS	TCAS II	Not fitted
Alert	RA	N/A
Separation		
Reported	200ft V/<1/4nm H	1000ft V/2nm H
Recorded		800ft V/0.5nm H

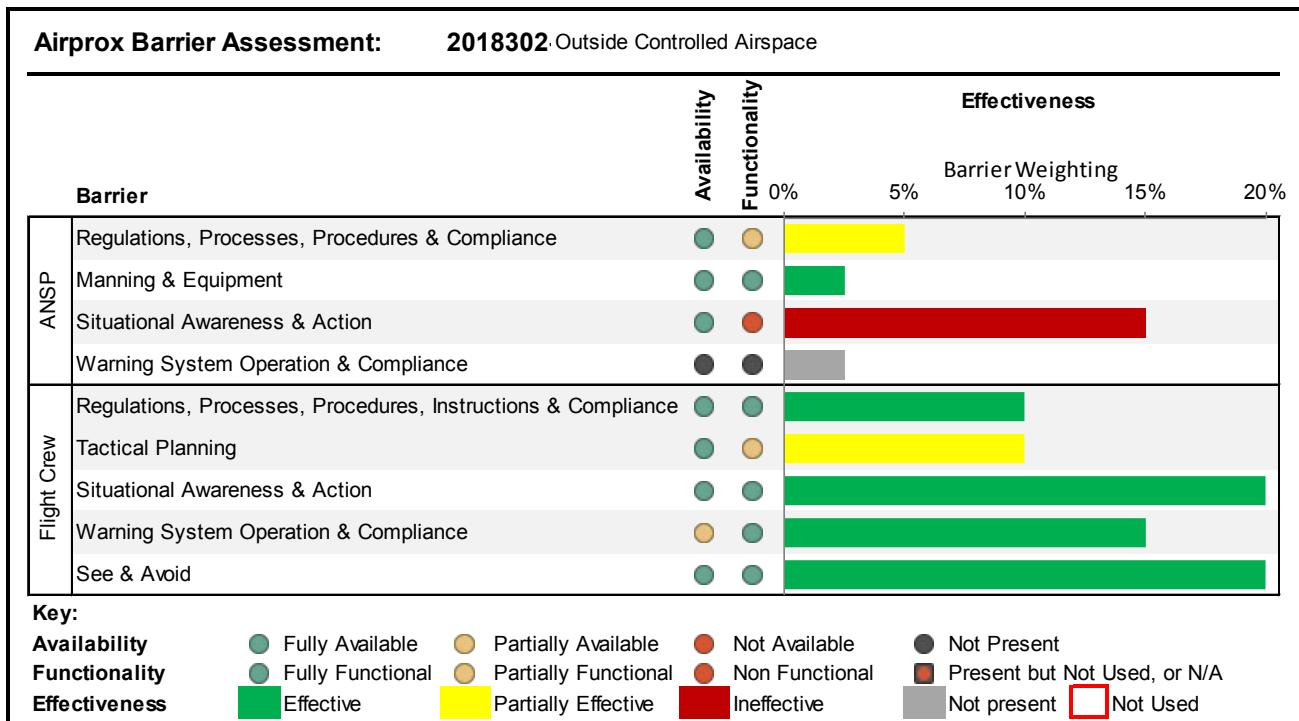
Flight Crew:

Tactical Planning was assessed as **partially effective** because the PA28 pilot chose not to request a Traffic Service in the AIAA.
