**AIRPROX REPORT No 2018303**

Date: 29 Sep 2018 Time: 1315Z Position: 5035N 00409W Location: Dartmoor

**PART A: SUMMARY OF INFORMATION REPORTED TO UKAB**

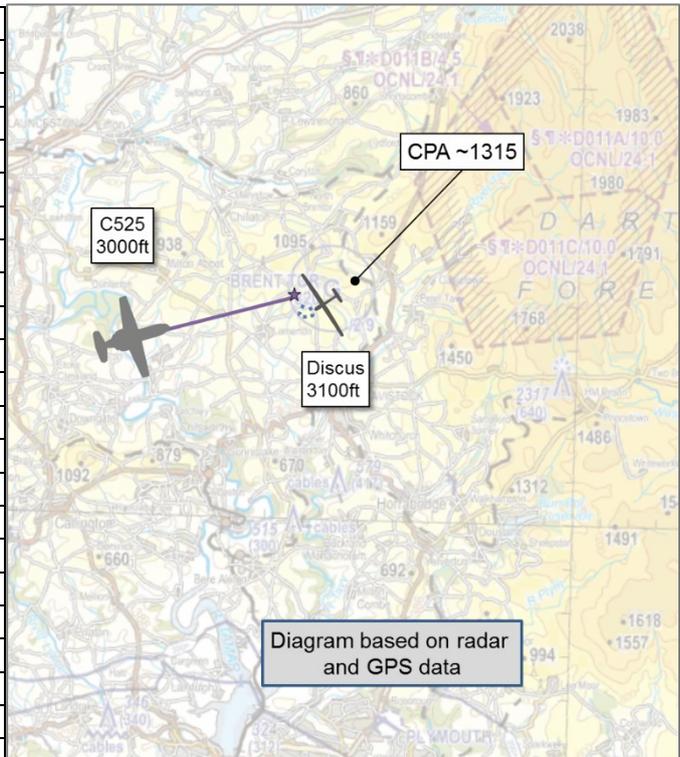
**THE DISCUS PILOT** reports that he was soaring locally to his launch site when he heard jet noise. The jet had flown past below and ‘to one side’ before he managed to see it and so there was no opportunity to take avoiding action. He noted that the aircraft had been seen about an hour earlier flying eastbound, but on that occasion was above the gliders soaring at 1500ft and there was some concern that it had overflowed twice and was not visual with the gliders.

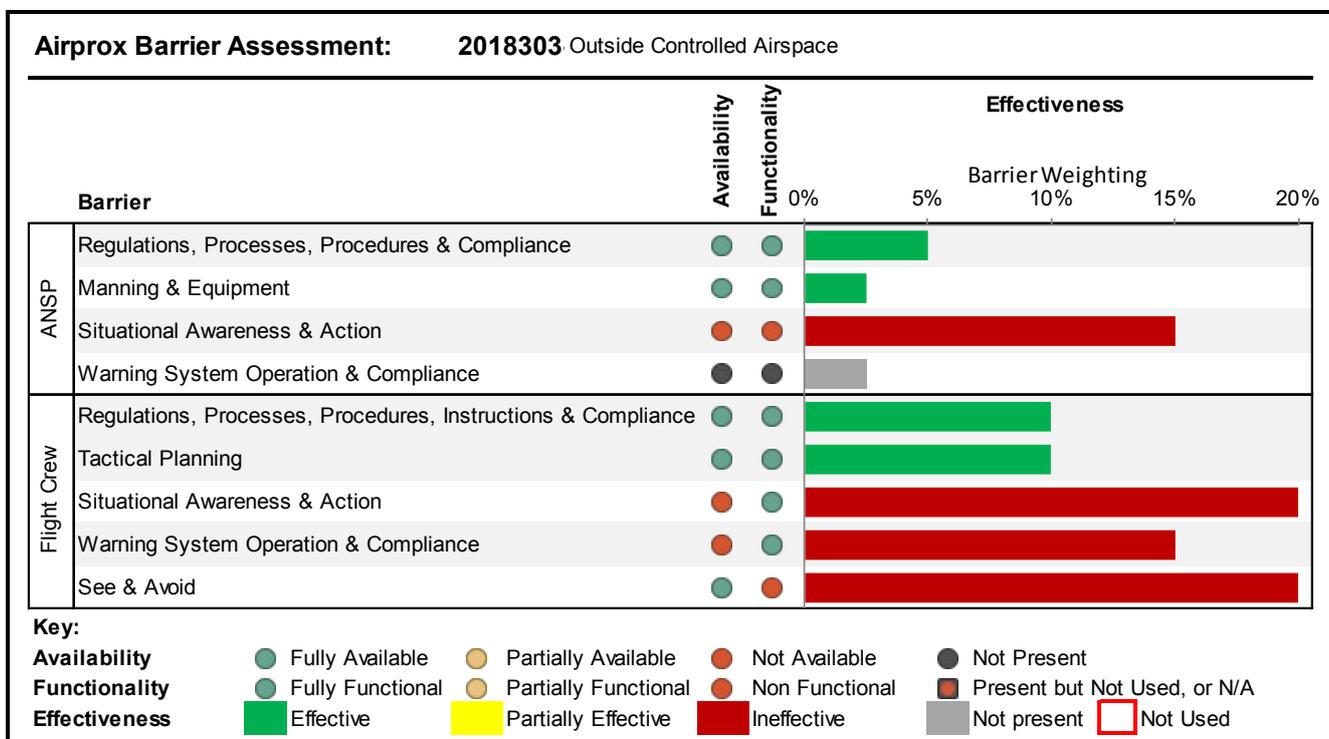
**Warning System Operation and Compliance** were assessed as **ineffective** because the FLARM on the glider and the TCAS II on the C525 were incompatible.

**See and Avoid** were assessed as **ineffective** because the glider pilot saw the C525 as it flew past, and, although the C525 pilot reported seeing a glider, it was assessed that this was probably not the glider in question.
