AIRPROX REPORT No 2018304

Date: 17 Nov 2018 Time: 1124Z Position: 5135N 00104W Location: RAF Benson - elev 203ft

PART A: SUMMARY OF INFORMATION REPORTED TO UKAB

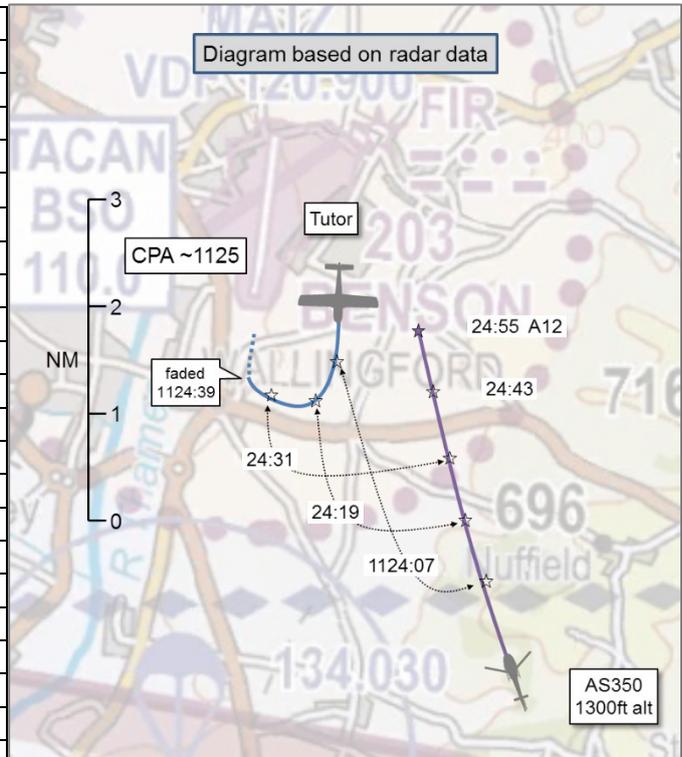
Recorded	Aircraft 1	Aircraft 2
Aircraft	Tutor	AS350
Operator	HQ Air (Trg)	Civ Helo
Airspace	ATZ	ATZ
Class	G	G
Rules	VFR	VFR
Service	ACS	None
Provider	Benson	N/A
Altitude/FL	1200ft	1300ft
Transponder	A,C,S	A,C,S
Reported		
Colours	Blue/white	Multi coloured
Lighting	Strobe	NK
Conditions	VMC	VMC
Visibility	8km	7km
Altitude/FL	NK	1000ft
Altimeter	QFE (1020hPa)	NK
Heading	010°	254°
Speed	NK	60kt
ACAS/TAS	TAS	Unknown
Alert	None	Unknown
Separation		
Reported	1nm H	Not seen
Recorded	NK (200ft V/0.3nm H ¹)

¹ Although the separation at CPA from the Grob Tutor is not known, the AS350 subsequently flew past another aircraft on the downwind leg at the separation stated.

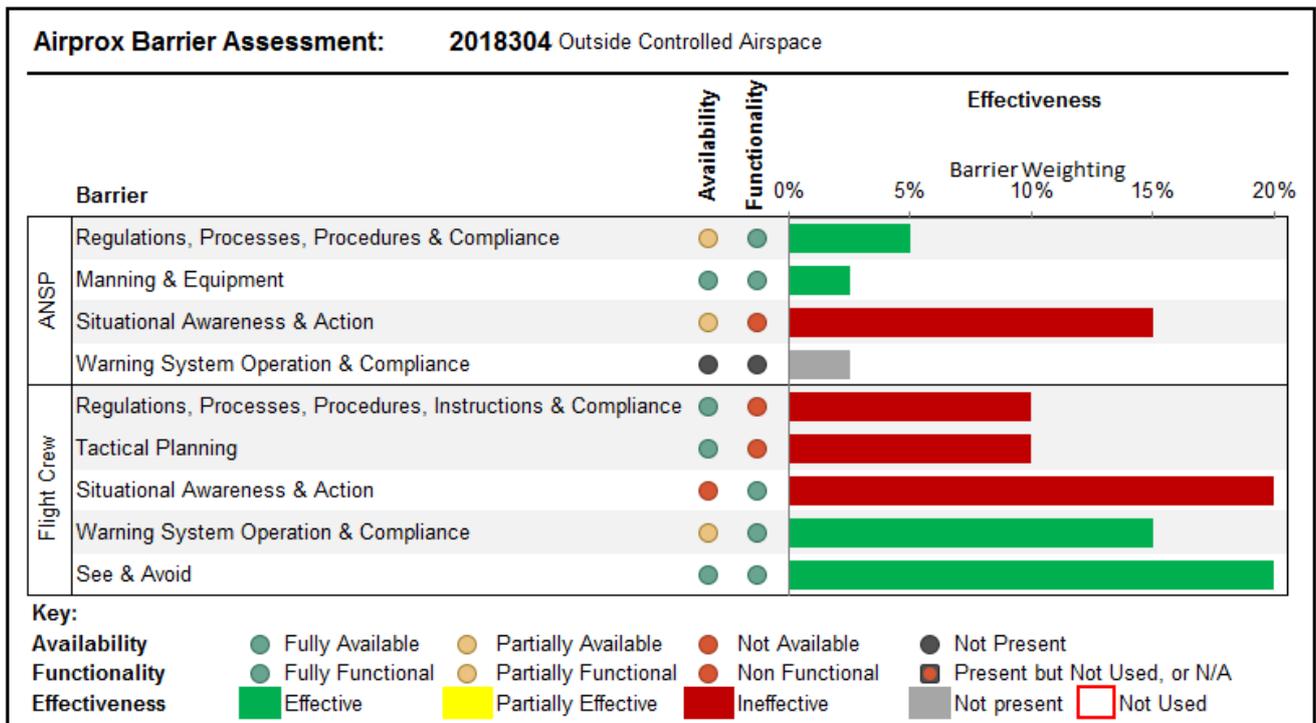
Situational Awareness and Action were assessed as **not available** because neither ATC nor other pilots in the Benson circuit were aware of the presence of the AS350 until the Tutor pilot obtained visual contact with the helicopter and reported its position on the R/T.

Warning System Operation and Compliance were assessed as **partially available** because only the Tutor was equipped with an electronic warning system, and that did not provide its pilot with an alert.
