AIRPROX REPORT No 2018306

Date: 21 Nov 2018 Time: 1024Z Position: 5005N 00547W Location: Land's End

PART A: SUMMARY OF INFORMATION REPORTED TO UKAB

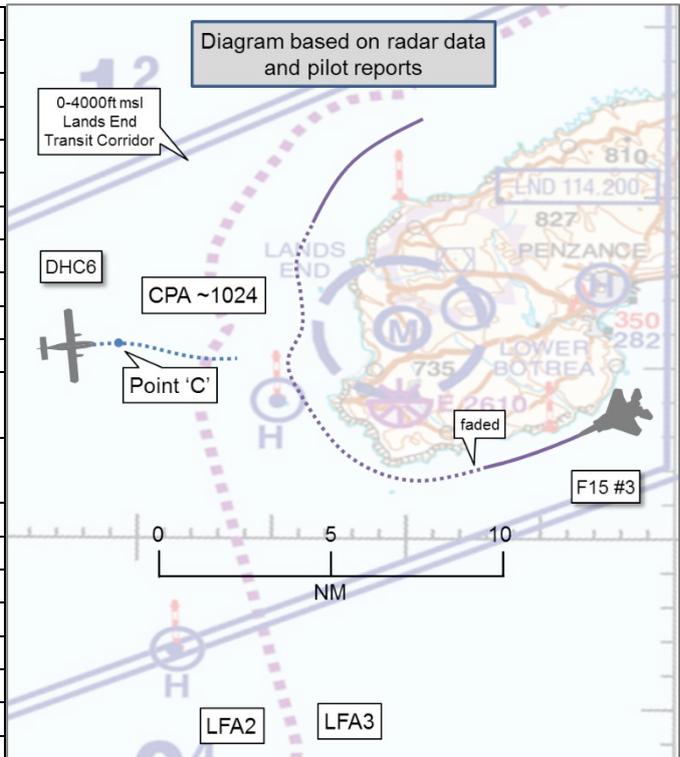
Recorded	Aircraft 1	Aircraft 2
Aircraft	DHC6	F15
Operator	CAT	Foreign Mil
Airspace	London FIR	London FIR
Class	G	G
Rules	VFR	VFR
Service	Basic	Basic
Provider	Land's End	Newquay
Altitude/FL		
Transponder	State/Modes	State/Modes
Reported		
Colours	White, black, red, blue	Grey
Lighting	Nav, anti-col, strobes	Anti-col, nav
Conditions	VMC	VMC
Visibility	30km	30km
Altitude/FL	1000ft	1500ft
Altimeter	QNH (1005hPa)	Rad Alt
Heading	070°	020°
Speed	135kt	450kt
ACAS/TAS	TCAS II	Not fitted
Alert	None	N/A
Separation		
Reported	0ft V/0.5nm H	500ft V/2nm H
Recorded	NK
