**AIRPROX REPORT No 2018313**

Date: 30 Nov 2018 Time: 1330Z Position: 5046N 00150W Location: Bournemouth

**PART A: SUMMARY OF INFORMATION REPORTED TO UKAB**

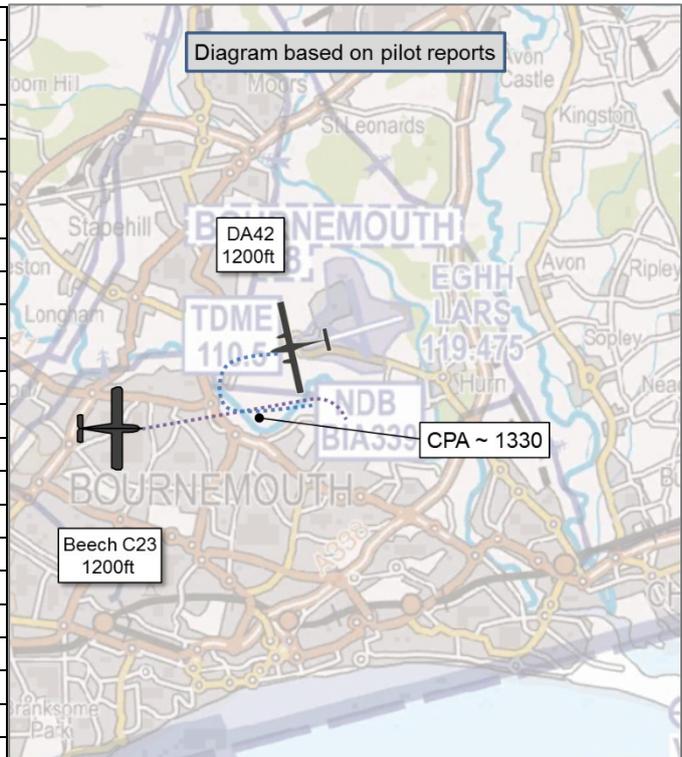
**THE DA42 PILOT** reports that he was conducting circuits on a student training sortie. During a left-hand climbing turn onto the downwind leg for RW26, another aircraft was suddenly spotted just to the right, slightly ahead and at an similar altitude. The student in the left seat was first to see it, the instructor was initially unsighted due to the engine nacelle and raised wing. Whilst in the turn onto downwind they had a limited view into the area that the other aircraft was coming from and they had been naturally looking into the turn to judge the downwind position. The student estimated that other aircraft came within 150m on this initial pass. The joining aircraft (subsequently identified as a Beech C23) ended up positioned ahead and to the left of the DA42 and at the same altitude. ATC then advised the DA42 crew that they were 'No1 to traffic on short finals' and seemed to be unaware that there was also a BE23 on the downwind leg. The BE23 then suddenly performed a right-turn, which took it across the path of the DA42, whereupon the instructor took control and climbed above the BE23 which passed underneath by approximately 2-300ft and 150m laterally. A subsequent discussion with ATC indicated that the BE23 was not showing on the ATM or the radar.
