AIRPROX REPORT No 2018002

Date: 04 Jan 2018 Time: 1345Z Position: 5302N 00024W Location: RAF Cranwell MATZ

PART A: SUMMARY OF INFORMATION REPORTED TO UKAB

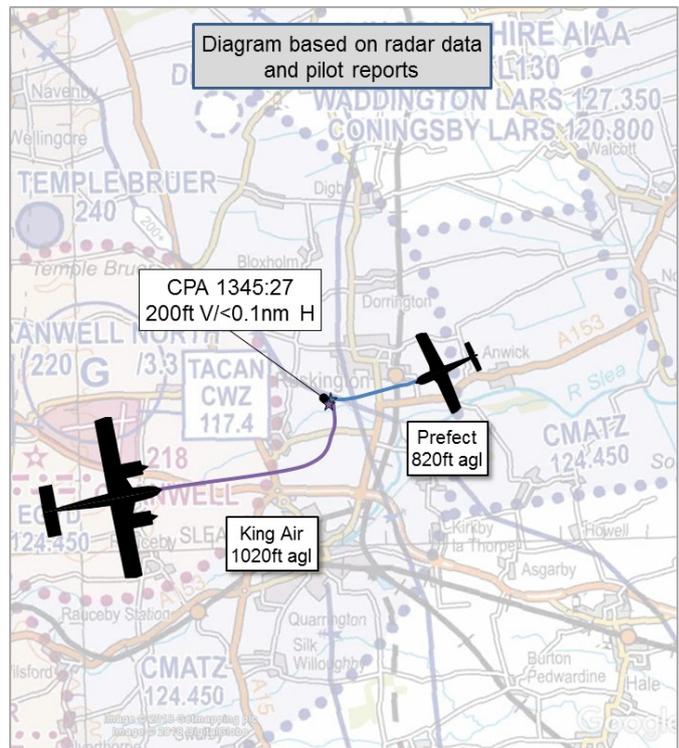
THE PREFECT PILOT reports that he was instructing a GH/IF sortie. The recovery consisted of a PAR to RAF Cranwell. Just after receiving their final clearance on the PAR, at approximately 3.5nm and 950–1000ft, the TAS sounded with a Traffic call. The handling pilot was instructed to continue his approach, whilst he, as the non-handling safety pilot, looked for the traffic. The TAS indicated the 10 o'clock and, on looking to that side of the aircraft, a King Air was spotted just below and in a left-hand turn towards his aircraft. He took control and initiated a go-around with a climbing turn to position above and behind the King Air. Approximately 1sec after he initiated the avoiding action, the King Air was seen to increase his AoB, as if to take his own avoiding action. The minimum separation was assessed as approximately 150m.

THE KING AIR PILOT reports that he had returned to RAF Cranwell on a simulated asymmetric ILS approach to RW26 but ATC had directed them to break off the approach and join the visual circuit. He elected to remain simulated asymmetric for a subsequent circuit to touch-and-go for further circuits. He extended upwind on the deadside and turned prior to Caythorpe (approximately 4nm west) to re-join downwind. As they called re-joining downwind, Cranwell Tower informed them of instrument traffic at 7 miles so he continued the downwind leg. Just prior to reaching abeam the landing threshold, ATC informed them that the instrument traffic was at 4 miles. The student pilot then called for the gear to be selected down, which he discussed with him regarding what he now expected to do with traffic at 4 miles. The student stated the best plan would be to leave the gear up and go-around at circuit height, which he did. At 1000ft on the QFE (977hPa), and abeam the 400ft point, the student, as the handling pilot, commenced a level left-hand turn to position on the deadside again. Although not visual with the

instrument traffic he, as the QFI, calculated it was safe to turn at 1000ft at their current position believing that the Prefect would be separated from them vertically and/or laterally. There was also no traffic indicated on TCAS which reinforced his 'mental picture' of being separated from the Prefect. After they called going-around at circuit height, the student pilot states he heard another radio call from ATC giving the position of the Prefect at 3 miles. At this time, the instructor's attention was focused on looking up the approach lane to visually acquire the inbound traffic, which would be on his side of the aircraft. After approximately 90° of left turn from the downwind heading (of 085 degrees), he became visual with the Prefect in his right 2 o'clock position. It appeared to be very slightly above them through the aircraft DV window, and holding a constant position relative to them. He took control of the aircraft and increased the angle of bank from 30° to 50-55°, lowered the nose slightly descending to 850ft, and also began to reset symmetric power. The student pilot became visual with the Prefect as he continued the turn; it climbed into the airfield overhead. He climbed the aircraft back to 1000ft and positioned on the deadside. A further circuit was flown from which they were sent around at circuit height for instrument traffic. The subsequent circuit was flown to land without incident. Prior to the sortie, he had asked the student to book a PD to fly an instrument approach away from Cranwell. He tried Humberside (who were unable to accept him), Marham (who couldn't accept him for an instrument approach), Coningsby (who were closed) and so, with R313 active and Waddington above their crosswind limits, Cranwell was the only available local option. Whilst on approach to Cranwell he could hear on the radio that the circuit was busy but was now fully open without a restriction on the number of aircraft that had been in place when he took off 45 minutes earlier. At no point during this incident did the other aircraft appear on TCAS.
