AIRPROX REPORT No 2018040

Date: 25 Mar 2018 Time: 1005Z Position: 5317N 00057W Location: Gamston

PART A: SUMMARY OF INFORMATION REPORTED TO UKAB

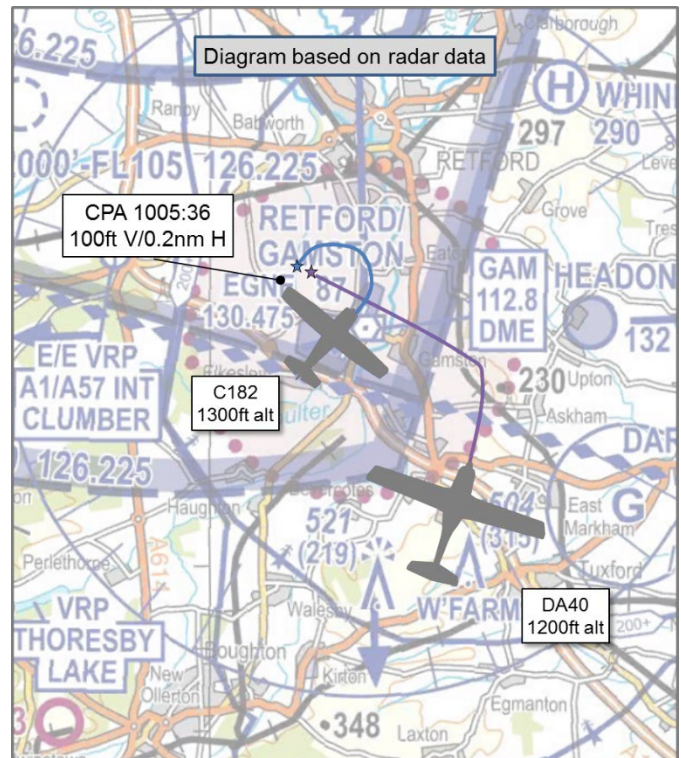
Recorded	Aircraft 1	Aircraft 2
Aircraft	C182	DA40
Operator	Civ Club	Civ Pte
Airspace	London FIR	London FIR
Class	G	G
Rules	VFR	VFR
Service	AGCS	AGCS
Provider	Gamston	Gamston
Altitude/FL	1300ft	1200ft
Transponder	A, C, S	A, C, S
Reported		
Colours	White, Red	White
Lighting	Beacon	Strobes
Conditions	VMC	VMC
Visibility	>10km	>10km
Altitude/FL	1400ft	1000ft
Altimeter	QNH (1012hPa)	QFE
Heading	210°	210°
Speed	100kt	100kt
ACAS/TAS	Not fitted	Not fitted
Separation		
Reported	30ft V/0m H	75ft V/0m H
Recorded	100ft V/0.2nm H
