AIRPROX REPORT No 2018091

Date: 19 May 2018 Time: ~1330Z Position: 5435N 00307W Location: 0.5nm SE Keswick

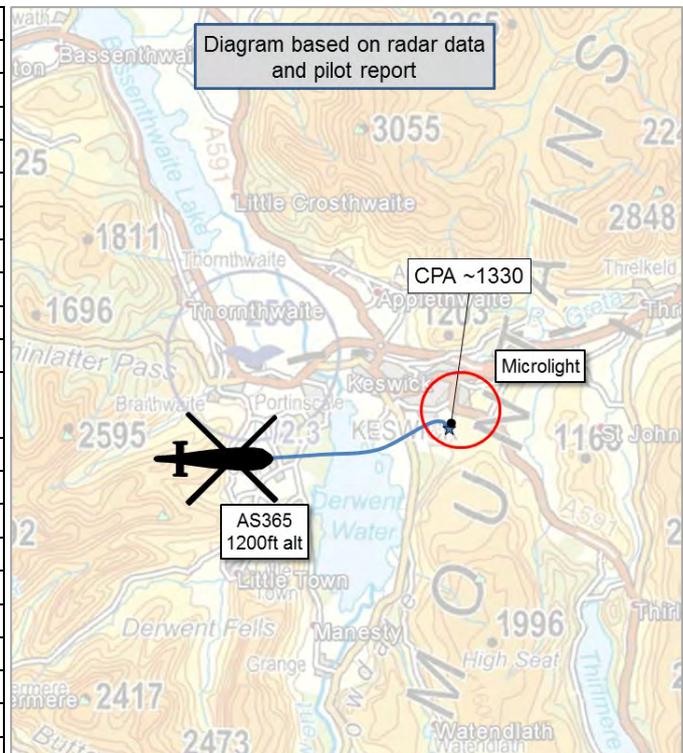
Recorded	Aircraft 1	Aircraft 2
Aircraft	AS365	Microlight
Operator	HEMS	Civ FW
Airspace	London FIR	London FIR
Class	G	G
Rules	VFR	VFR
Service	Listening Out	
Provider	London Info ¹	
Altitude/FL	1200ft	
Transponder	A, C, S	
Reported		
Colours	White, Green, Yellow	
Lighting	Nav, Strobe	
Conditions	VMC	
Visibility	>10km	
Altitude/FL	600ft	
Altimeter	QNH (1020hPa)	
Heading	050°	
Speed	130kt	
ACAS/TAS	TCAS I	
Alert	None	
Separation		
Reported	400ft V/0.5nm H	
Recorded	NK

THE AS365 PILOT reports that he had descended below 1000ft agl near Keswick to avoid multiple gliders and para-gliders using the up-drafting slopes and that there had been no answer from Latrigg Fell launch site or gliders on 129.975 when he called on that frequency. He spotted the microlight late, above to the 12 o'clock and closing, and recalled making an avoiding left turn to maintain separation; there was no apparent avoiding action from the microlight. Another 5 (at least) microlights were then spotted routing east to west from the Penrith area to Keswick before there was any confliction. He thought that they may have been conducting a navigation event and opined that transponders on microlights would have aided identification and helped with TCAS warnings. Additionally, a Low-Level and/or open-air-space VHF common frequency for blind calls would have been helpful. He commented that London Info were very busy and could not have helped even if he could have got a call to them.

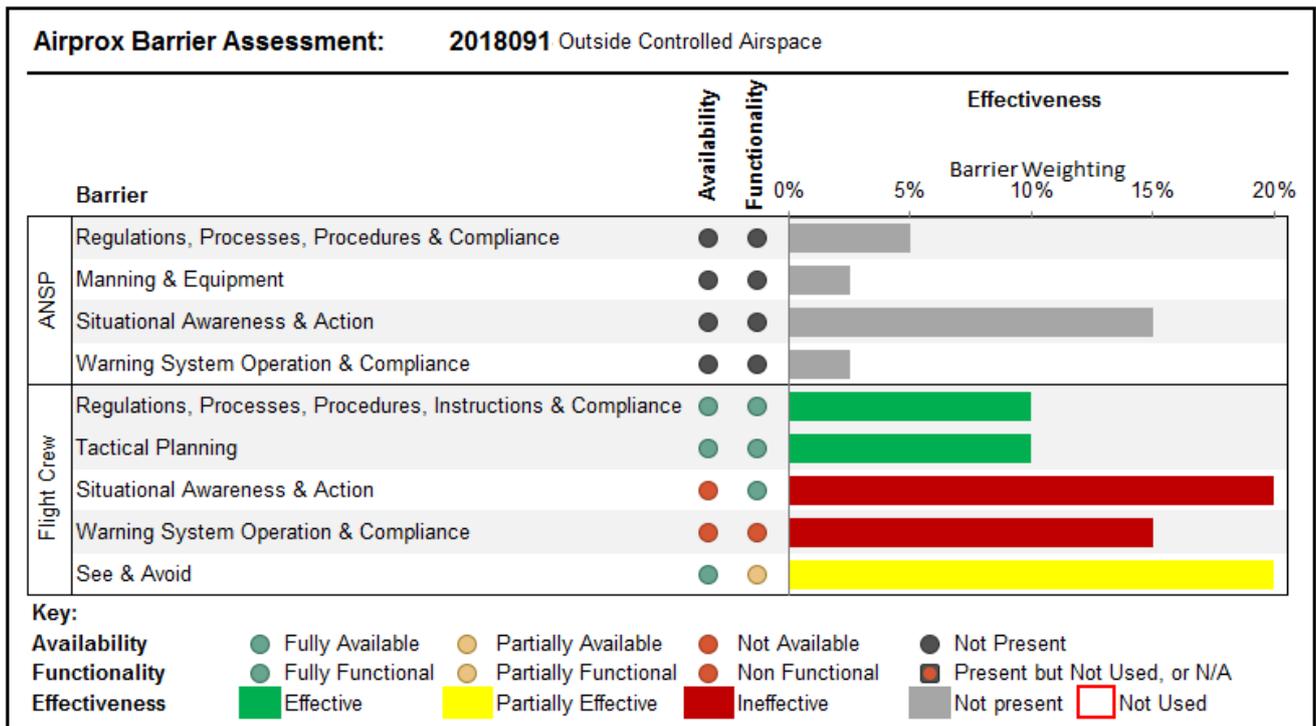
In assessing the effectiveness of the safety barriers associated with this incident, the Board concluded that the key factors had been that:

Flight Crew:

Situational Awareness and Action were assessed as **ineffective** because neither pilot had any SA on the other aircraft.

Warning System Operation and Compliance were assessed as **ineffective** because the microlight did not appear to have a transponder and therefore could not interact with the AS365's TCAS to alert the AS365 pilot to the presence of the microlight.

See and Avoid were assessed as **partially effective** because the AS365 pilot saw the microlight late and took appropriate avoiding action. It is not known if the microlight pilot saw the AS365.
