**AIRPROX REPORT No 2018105**

Date: 02 Jun 2018 Time: 1020Z Position: 5146N 00031E Location: Boreham airfield

**PART A: SUMMARY OF INFORMATION REPORTED TO UKAB**

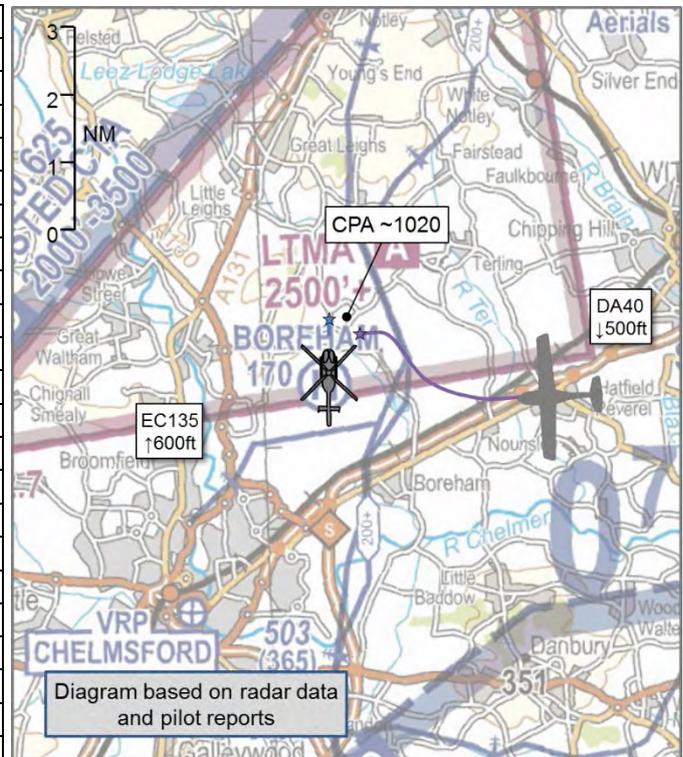
Recorded	Aircraft 1	Aircraft 2
Aircraft	EC135	DA40
Operator	NPAS	Civ FW
Airspace	London FIR	London FIR
Class	G	G
Rules	VFR	VFR
Service	None	Basic
Provider		Southend
Altitude/FL	NK	NK
Transponder	A, C, S	A, C, S
<b>Reported</b>		
Colours	Blue/Yellow	
Lighting	Strobes, HISLs	Strobes, Nav
Conditions	VMC	VMC
Visibility	>10km	10km
Altitude/FL	350ft	800ft
Altimeter	QNH (1018hPa)	QNH (1019hPa)
Heading	010°	230°
Speed	55	88kt
ACAS/TAS	TCAS I	Not fitted
Alert	None	N/A
<b>Separation</b>		
Reported	0ft V/0.5nm H	500ft V/1nm H
Recorded	NK
