AIRPROX REPORT No 2018124

Date: 03 Jun 2018 Time: 0912Z Position: 5155N 00102W Location: 3nm S Buckingham

PART A: SUMMARY OF INFORMATION REPORTED TO UKAB

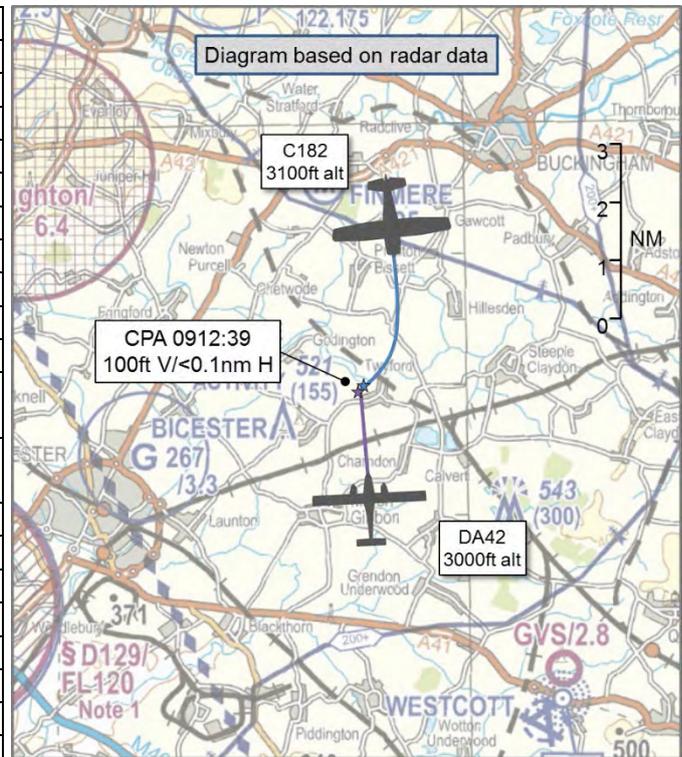
THE C182 PILOT reports that they were operating at 3000ft in VFR conditions; the cloud was few at 2500ft, but they were manoeuvring in an area of about 10nm which was clear of cloud. They saw a DA42 climbing through 2900ft on a reciprocal track. It had been hard to identify due to its 'slick' appearance and white colour against the cloud. They first saw it at 0.25nm and took avoiding action by climbing and lazy-banking to the left, once passed it appeared that the DA42 had also taken evasive action.

THE DA42 PILOT reports that he was flying a training flight in good weather conditions. They did some clearing turns prior to stalling and, during the turns, he noticed an aircraft approaching from the left, a little higher. He turned to the right, the other aircraft continued on its way, and they continued with their exercise. He believed it was a late sighting by both pilots.

The Board quickly agreed that the cause of the Airprox was a late sighting by both pilots. In assessing the risk, the Board thought that the late sightings by both pilots and the associated lack of time available for them to take avoiding action (3-4 secs at their closing speed of 235kts at 0.25nm) made this a Category B incident where safety had been much reduced below the norm.

Cause: A late sighting by both pilots.
