AIRPROX REPORT No 2018182

Date: 15 Jul 2018 Time: 1319Z Position: 5141N 00147W Location: Fairford

PART A: SUMMARY OF INFORMATION REPORTED TO UKAB

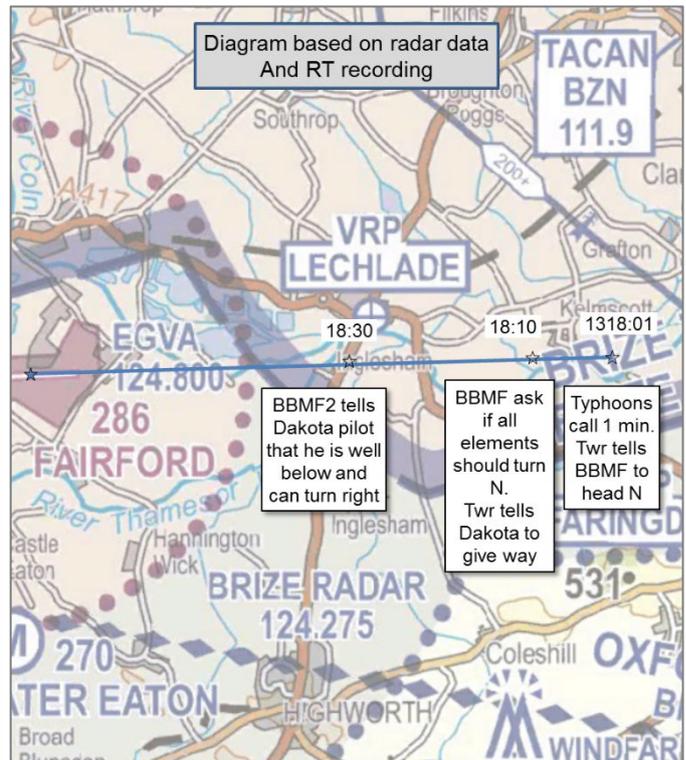
THE TYPHOON PILOT reports leading 9 Typhoons for a diamond-9 flypast at RIAT, Fairford tasked at 1315. They departed the hold on time at 1256:29 and at 1300:17 he requested that the Swanwick Mill controller relay to Fairford that they were on time. At 1300:43 he received a request to 'Rolex¹ 6 mins to new Time On Target (TOT) 1-3-1-9'. A 6 min Rolex did not match a 1319 TOT, so he requested clarification and, at 1301:29, the controller confirmed the new TOT as 1319. At 1302 he executed an unplanned orbit in transit formation to the north of the Malvern Hills, rolling out on time. He changed frequency to Fairford App once south of the Malvern Hills, as directed by the Swanwick controller. The remainder of the transit was uneventful and there was no mention of further delays. He asked one of the formation to confirm another formation's TOT with their lead aircraft on their in-flight frequency and he reported back that it was 1321, 2 mins behind their own, as expected. He formed the Diamond-9 at 1307:20. At 1314:03 he requested to change to Fairford Tower and was cleared to do so by Fairford App. He descended to flypast height and checked in to Fairford Tower at 1314:08 calling '{C/S} on time'. At this point he heard BBMF communication and was told to 'minimise' by their formation lead. He rolled out on 'line of attack' (LOA) at 1317:00, 2 mins to TOT. He called '{C/S} 2 mins' to which there was an unreadable response from the BBMF formation. At 1318:01 he called '1 min' and Fairford Tower told the BBMF formation to 'head north now please, fly-by running in'. The continued presence of BBMF caused him some concern and he considered aborting to the south but discounted this as more dangerous than a fly through because he had insufficient situational awareness on other holding aircraft. At this point he saw the Dakota south of his LOA turning towards, slightly low and, at 1318:10, Fairford Tower instructed the Dakota to give way to the Typhoon formation. The Typhon pilot assessed there was a low risk of collision with the Dakota and he continued to search for the other BBMF aircraft, but didn't see them as his formation flew through. The Typhoon flypast occurred at 1319:08.

THE BBMF FORMATION PILOT reports that whilst on the ground the formation was advised that the display was running on time. This information is used for engine start times to avoid overheating the fighter aircraft and is therefore key information. However, a pair of aircraft ahead were taking off 4 mins late, so the BBMF pilot asked for confirmation that the display was actually running 4 mins late. The response from the Ground controller was that it was 3 mins late. They were delayed further by FOD on the runway, further delaying the display timings, and eventually took-off 9 mins after their original planned start time. During the latter part of their display the Typhoon formation were heard broadcasting '4 mins' on the display frequency. Believing it to be a formation on the wrong frequency, one of the BBMF formation instructed the station to minimise RT because the BBMF display has key radio communication requirements. At some stage subsequently there was a transmission that stated Typhoon in 3 mins, either from the Flying Display Director (FDD) or the Typhoon formation. The BBMF continued to display because the crews believed that they owned the airspace until the display was complete, which is standard air show procedure. As the BBMF fighters were conducting the re-join on the Lancaster as part of the final part of the display, the FDD transmitted words to the effect of '{BBMF C/S} go north now'. The Lancaster (No2) continued progressing north with the fighters (No3 and No4), but the Dakota (No1) which was south of the display line asked for confirmation that it too had to go north which would have resulted in it crossing the display line from off-crowd to on-crowd. The No3 saw the Typhoon formation well above and behind the Dakota and instructed the Dakota pilot to come right onto north, giving assurance that there was no immediate collision risk. The Dakota pilot, unable to see the Typhoon formation high in their 6 o'clock, turned right and descended 250ft to further increase separation. The Typhoon formation flew through and the BBMF continued for their last pass behind it.

THE FAIRFORD TOWER CONTROLLER reports that the BBMF formation were delayed on the runway due to FOD (a broken umbrella) and therefore rolled 7 mins later than their planned slot. The FDD informed him that the TOT for the Typhoon formation had been 'rolexed' by 4 mins to 1419 [1319]. This was passed to the BBMF with the additional information that 'there was no need to hurry'. This was not acknowledged by the BBMF, but this was put down to their need to minimise RT. During the display, the FDD asked how their display finished, but because the formation had landed at the end of the display the previous day and were not landing on this day, the Tower controller did not know. The previous day the Dakota had landed following his solo routine (leaving the fighters and Lancaster to complete their display), so the Tower Controller assumed that once the Dakota had vacated the display area, the aircraft would continue en-route to its final destination. At 1416 [1316] the Typhoon formation reported 2 mins to run-in, to which the BBMF told them to minimise RT. The Typhoon formation reported running in and at this time, unbeknown to the controller, the Dakota had split from the formation and was holding to the south of the display area as the Lancaster and fighters were running in on the 45° axis from the NW to turn NE at the datum. He was visual with the BBMF and the Typhoon running in from the east, and judged there was sufficient separation. However, as the BBMF turned over the datum, the FDD instructed him to break the BBMF onto 360°. Out of his line of sight, to the south of the airfield, the Dakota also appeared to take the 360° heading and flew towards the Typhoon formation. Whilst he was monitoring the inbound progress of the Typhoon formation against the BBMF Lancaster/fighter formation, the Tower Controller saw the Dakota appear from the south-east. Due to the proximity of the Dakota to the Typhoon formation, he only had time to pass Traffic Information both ways and both elements reported in sight and passed well clear.
