## AIRPROX REPORT No 2018212

Date: 14 Aug 2018 Time: 1443Z Position: 5225N 00040E Location: Lakenheath

### PART A: SUMMARY OF INFORMATION REPORTED TO UKAB

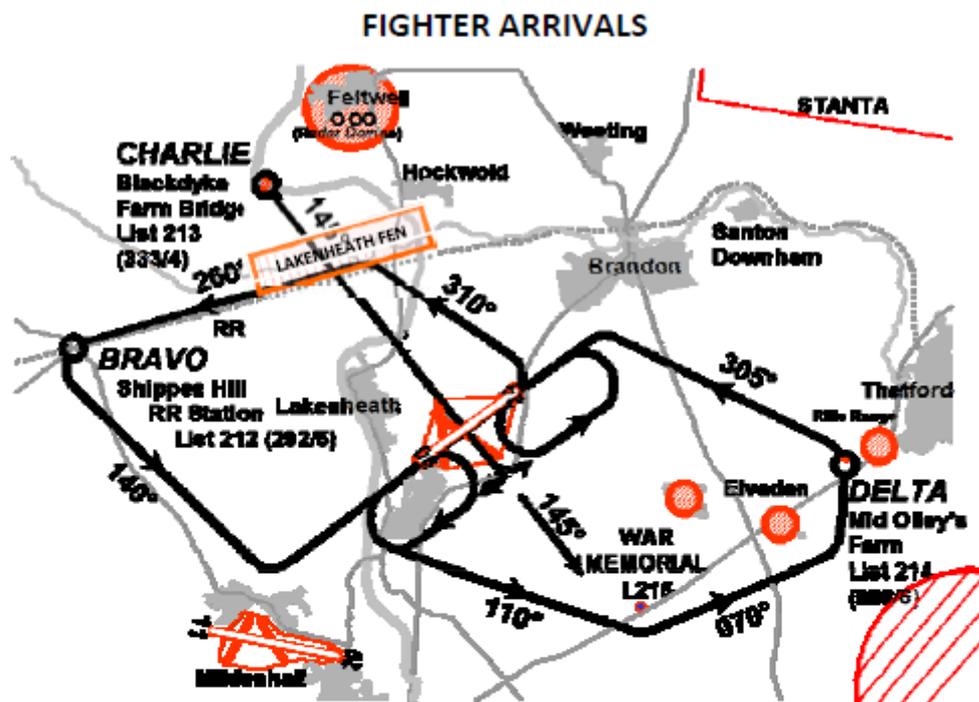
At Figure 1 is a guide to arrivals at RAF Lakenheath:

**RWY 06:** Recover via PT BRAVO or PT CHARLIE.

**RWY 24:** Recover via PT DELTA, DIRECT INITIAL, or PT CHARLIE.

**INITIAL:** Rpt 3nm INITIAL. Do not overfly Brandon.
