**AIRPROX REPORT No 2018280**

Date: 11 Oct 2018 Time: 1210Z Position: 5338N 00031W Location: ivo Doncaster

**PART A: SUMMARY OF INFORMATION REPORTED TO UKAB**

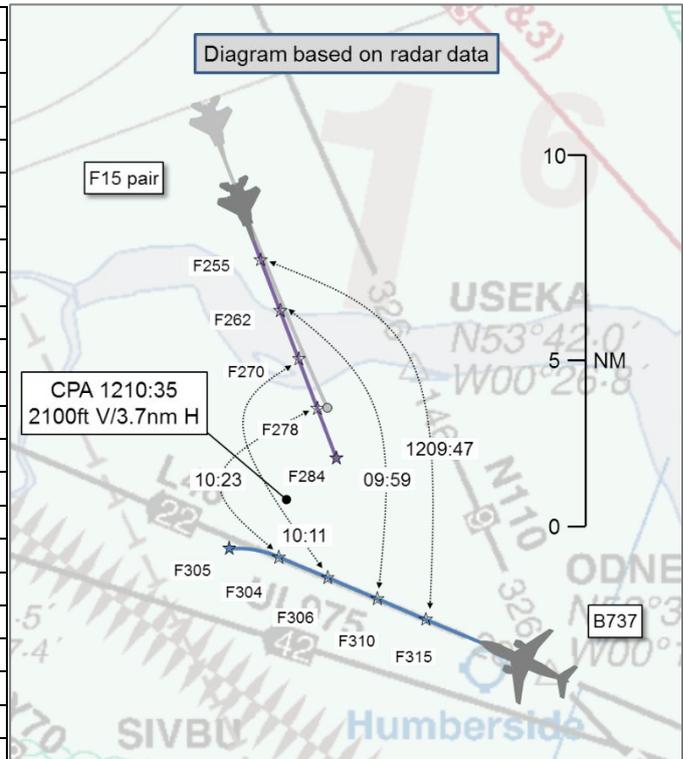
Recorded	Aircraft 1	Aircraft 2
Aircraft	B737	F15E
Operator	CAT	Foreign Mil
Airspace	UAR	UIR
Class	C	C
Rules	IFR	VFR
Service	Radar Control	Traffic <sup>1</sup>
Provider	Prestwick Centre	Swanwick Mil
Altitude/FL	FL305	FL283
Transponder	A,C,S	A,C
Reported		
Colours	Company	
Lighting	Strobes, nav	NK
Conditions	VMC	VMC
Visibility	NK	8000km
Altitude/FL	FL305	FL280
Heading	270°	SW
Speed	280kt	300kt
ACAS/TAS	TCAS II	Not fitted
Alert	TA	N/A
Separation		
Reported	Not seen	Not seen
Recorded	2200ft V/3.9nm H

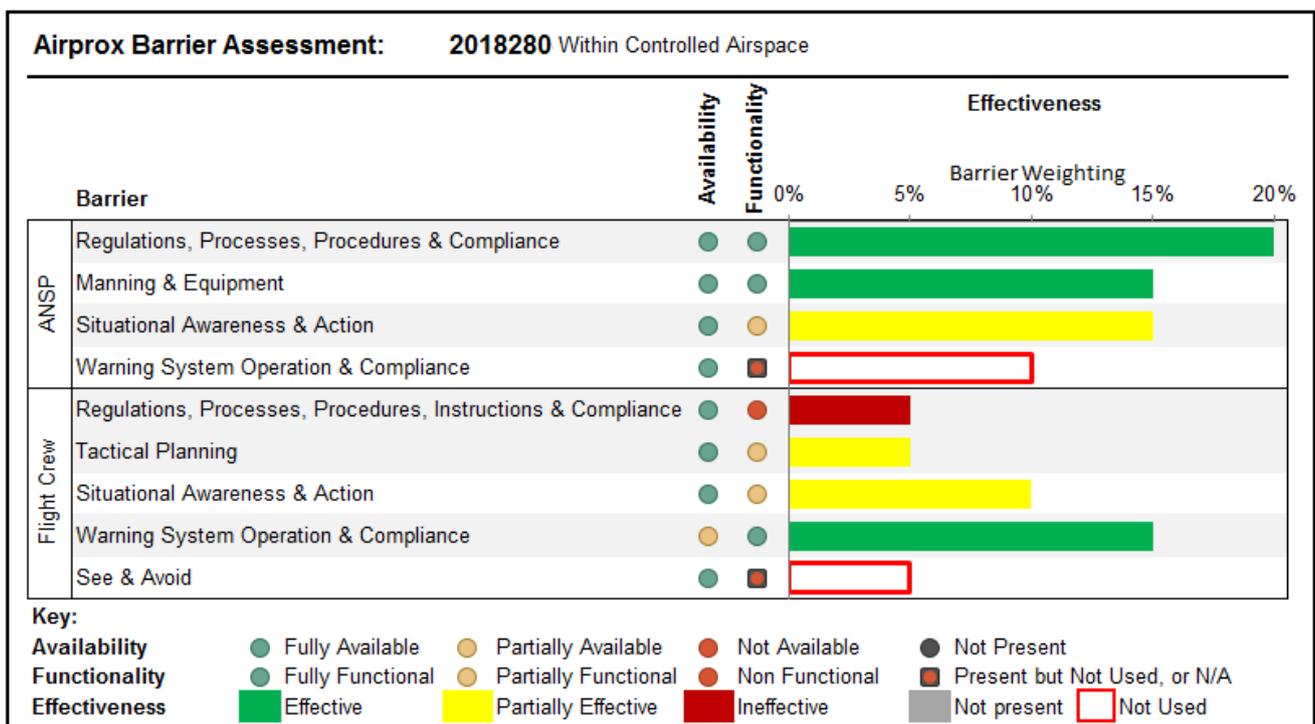
**Warning System Operation and Compliance** were assessed as **partially available** because only the B737 was equipped with an electronic warning system.

**See and Avoid** was assessed as **not used** because the incident occurred at a range at which visual sighting and actions therefrom were not relevant.
