**AIRPROX REPORT No 2018320**

Date: 19 Dec 2018 Time: 1638Z Position: 5741N 00323W Location: Lossiemouth

**PART A: SUMMARY OF INFORMATION REPORTED TO UKAB**

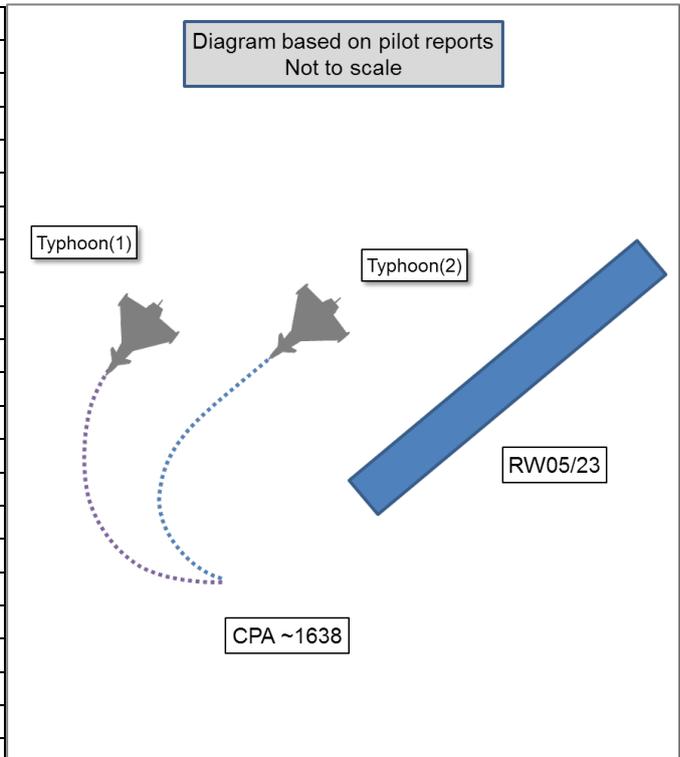
Recorded	Aircraft 1	Aircraft 2
Aircraft	Typhoon(2)	Typhoon(1)
Operator	HQ Air (Ops)	HQ Air (Ops)
Airspace	Lossiemouth ATZ	Lossiemouth ATZ
Class	G	G
Rules	VFR	VFR
Service	ACS	ACS
Provider	Lossie Tower	Lossie Tower
Altitude/FL	NK	NK
Transponder	A, C	A, C
<b>Reported</b>		
Colours	Grey	Grey
Lighting	Red anti-col, nav	NK
Conditions	VMC	VMC
Visibility	>10km	NK
Altitude/FL	NK	500ft
Altimeter	NK (994hPa)	NK
Heading	170°	NK
Speed	NK	190kt
ACAS/TAS	Not fitted	Not fitted
<b>Separation</b>		
Reported	120ft V/50ft H	'100-200ft'
Recorded	80ft V/58m H <sup>1</sup>

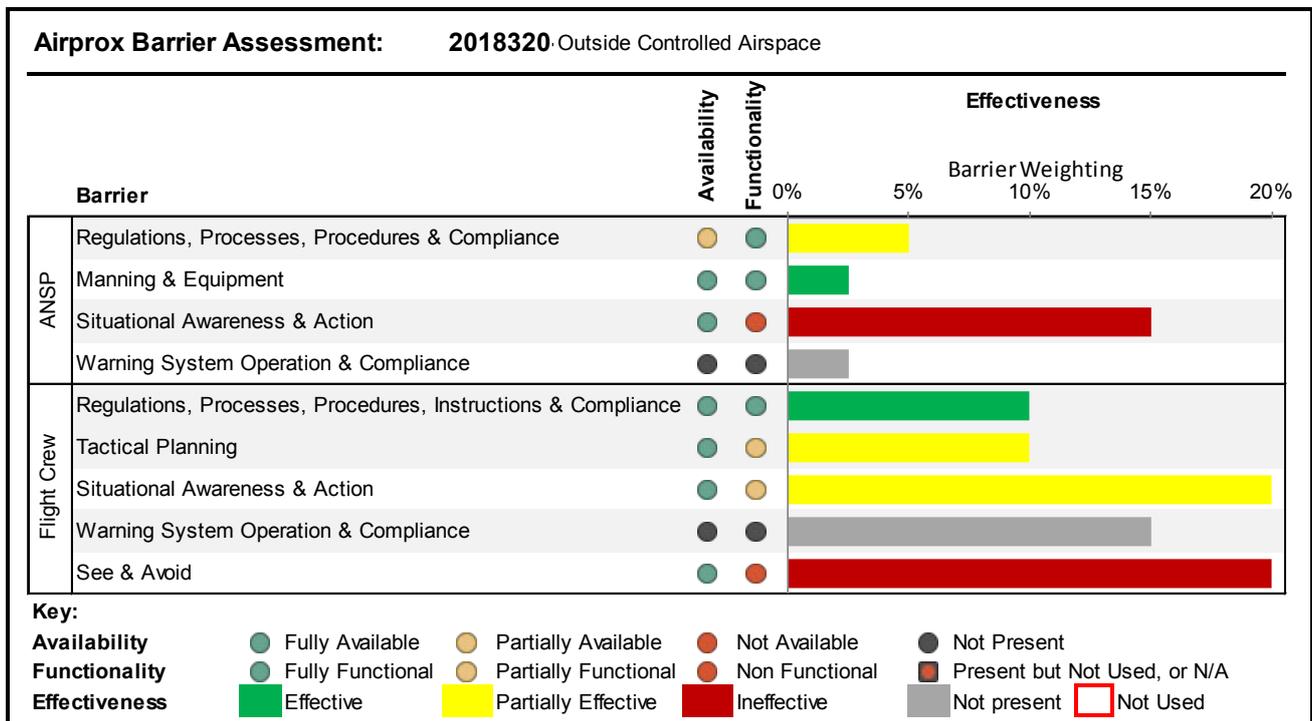
**Situational Awareness and Action** were assessed as **partially effective** because although Typhoon(2) pilot lost positional awareness on Typhoon(1), and mis-identified Typhoon B as Typhoon(1), he did ultimately receive situational awareness from his air-to-air TACAN and was then able to act to improve the situation.

**See and Avoid** were assessed as **ineffective** because neither Typhoon pilot saw the others' aircraft in time to take avoiding action.
