AIRPROX REPORT No 2019014

Date: 22 Jan 2019 Time: 1135Z Position: 5220N 00128W Location: Coventry Aerodrome

PART A: SUMMARY OF INFORMATION REPORTED TO UKAB

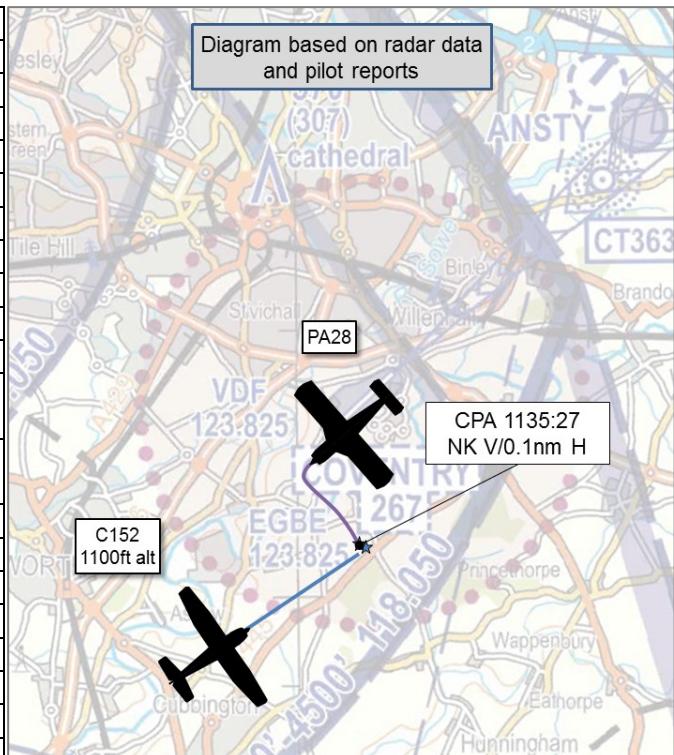
Recorded	Aircraft 1	Aircraft 2
Aircraft	C152	PA28
Operator	Civ FW	Civ FW
Airspace	Coventry ATZ	Coventry ATZ
Class	G	G
Rules	VFR	VFR
Service	AFIS	AFIS
Provider	Coventry	Coventry
Altitude/FL	1100ft	NK
Transponder	A, C, S	A
Reported		
Colours	Blue, Black	White, Red, Black
Lighting	Landing, Nav, Beacon	Nav
Conditions	VMC	VMC
Visibility	>10km	>10km
Altitude/FL	1300ft	1000ft
Altimeter	QNH (1001hPa)	NK (990hPa)
Heading	050°	140°
Speed	90kt	90kt
ACAS/TAS	Not fitted	Not fitted
Separation		
Reported	0ft V/<0.1nm H	150ft V/600m H
Recorded	NK V/0.1nm H

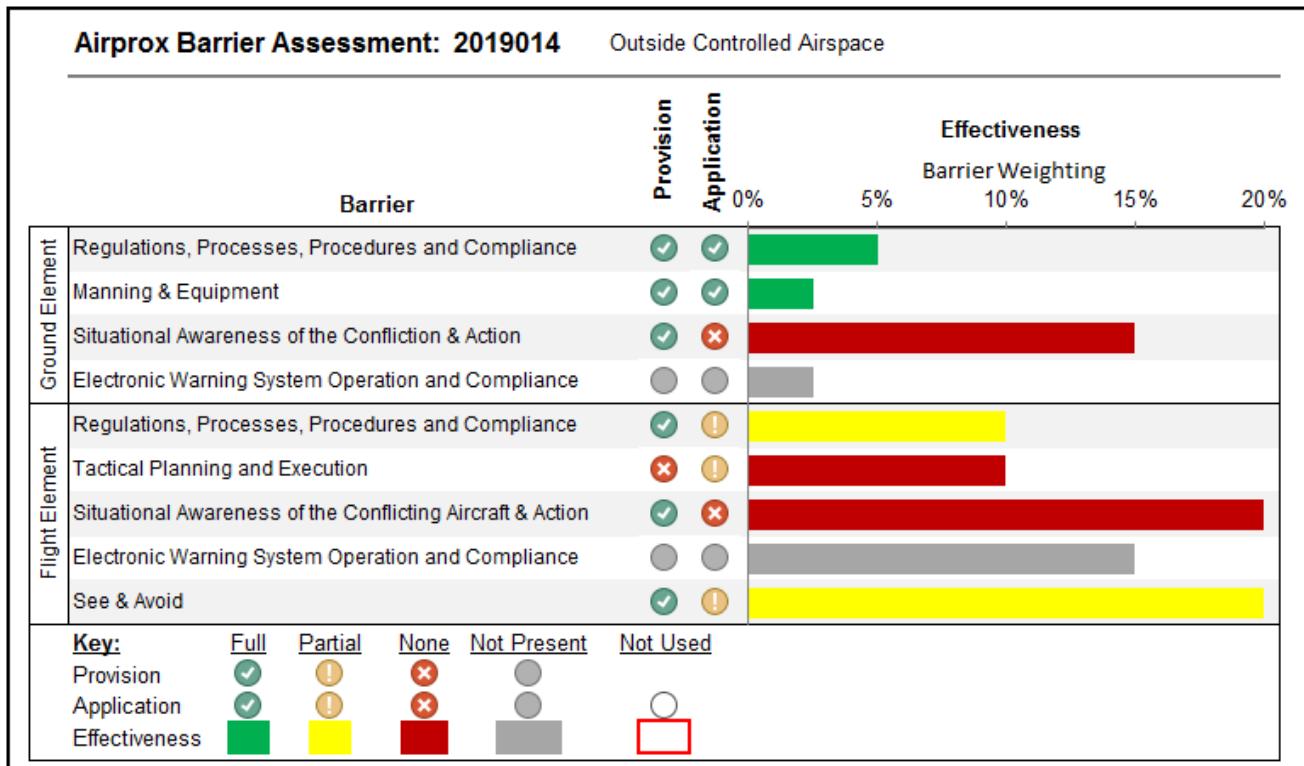
Situational Awareness and Action were assessed as **ineffective** because the C152 pilot did not integrate with the PA28 that they had been informed was taking-off into the visual circuit.

See and Avoid were assessed as **partially effective** because the PA28 pilot flew too close to the C152 ahead in the visual circuit.
