AIRPROX REPORT No 2019034

Date: 25 Feb 2019 Time: 1206Z Position: 5152N 00019W Location: Luton CTR

PART A: SUMMARY OF INFORMATION REPORTED TO UKAB

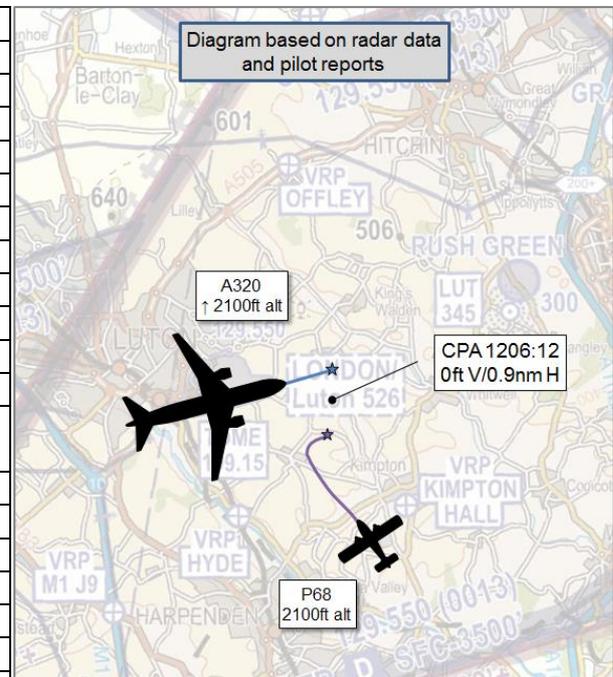
Recorded	Aircraft 1	Aircraft 2
Aircraft	A320	P68
Operator	CAT	Civ Comm
Airspace	Luton CTR	Luton CTR
Class	D	D
Rules	IFR	VFR
Service	ACS	ACS
Provider	Luton Tower	Luton Tower
Altitude/FL	2000ft	2100ft
Transponder	A, C, S	A, C, S
Reported		
Colours	Company	Not reported
Lighting	Beacon, Strobe, Nav	Not reported
Conditions	VMC	VMC
Visibility	Not reported	Not reported
Altitude/FL	2000ft	2400ft
Altimeter	QNH	NK
Heading	080°	NK
Speed	150kt	120kt
ACAS/TAS	TCAS II	Unknown
Alert	None	Unknown
Separation		
Reported	0ft V/<1nm H	Not reported
Recorded	0ft V/0.9nm H
