**AIRPROX REPORT No 2019035**

Date: 23 Feb 2019 Time: 1426Z Position: 5328N 00222W Location: Manchester Barton

**PART A: SUMMARY OF INFORMATION REPORTED TO UKAB**

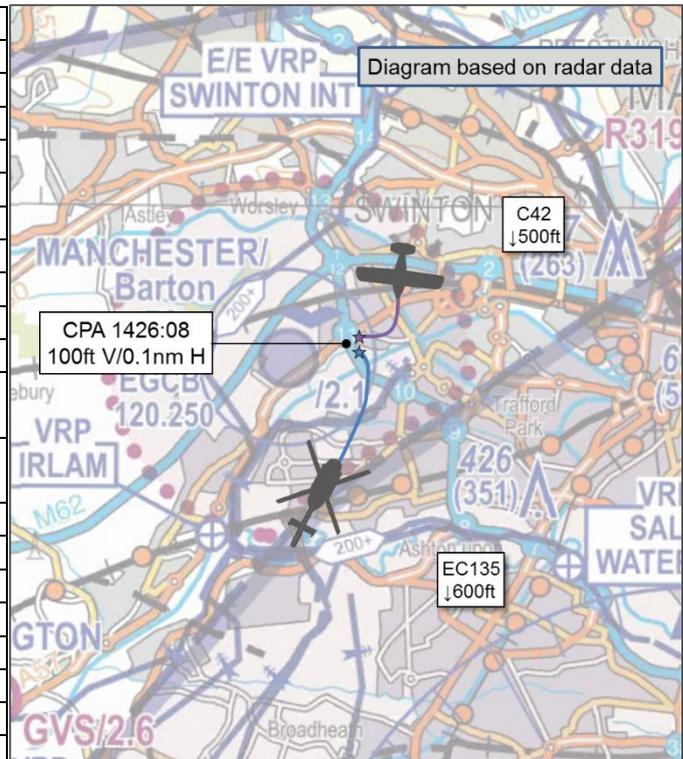
Recorded	Aircraft 1	Aircraft 2
Aircraft	EC135	Ikarus C42
Operator	HEMS	Civ FW
Airspace	Barton ATZ	Barton ATZ
Class	G	G
Rules	VFR	VFR
Service	AFIS	AFIS
Provider	Barton	Barton
Altitude/FL	600ft	500ft
Transponder	A, C, S	A, C, S
<b>Reported</b>		
Colours	Yellow, Blue	White, Red, Silver
Lighting	Nav, Landing, HISL, Searchlight	Landing
Conditions	VMC	VMC
Visibility	>10km	>10km
Altitude/FL	600ft	600ft
Altimeter	NK	QFE (1028hPa)
Heading	070°	260°
Speed	60kt	60kt
ACAS/TAS	TAS	Not fitted
Alert	None	N/A
<b>Separation</b>		
Reported	0ft V/200m H	150ft V/50m H
Recorded	100ft V/0.1nm H

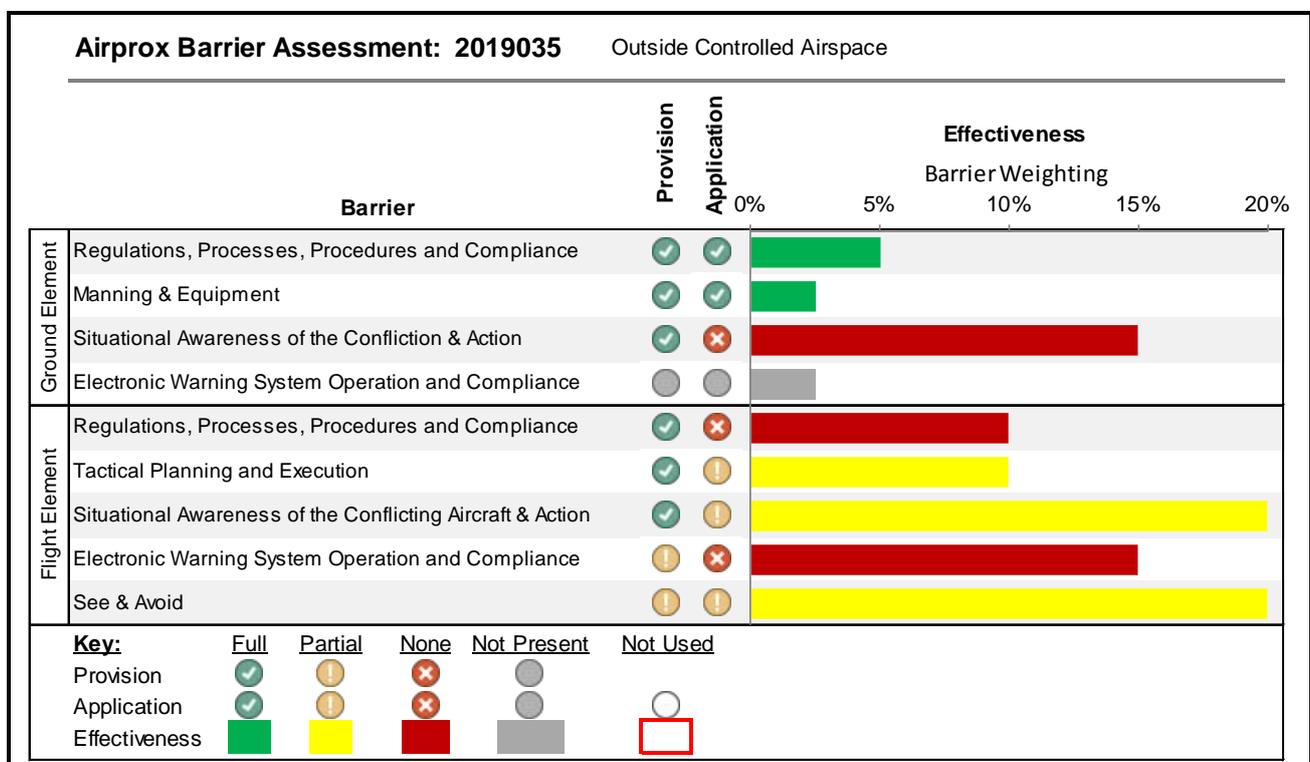
**Electronic Warning System Operation and Compliance** were assessed as **ineffective** because the TAS on the EC135 either did not alert, or was not assimilated by the pilot.

**See and Avoid** were assessed as **partially effective** because the EC135 crew did not see the C42 until after CPA and, although the C42 pilot was visual with the EC135 until the latter stages, he did not take early action to resolve the conflict.
