AIRPROX REPORT No 2019066

Date: 23 Feb 2019 Time: 1305Z Position: 5053N 00044W Location: Goodwood

PART A: SUMMARY OF INFORMATION REPORTED TO UKAB

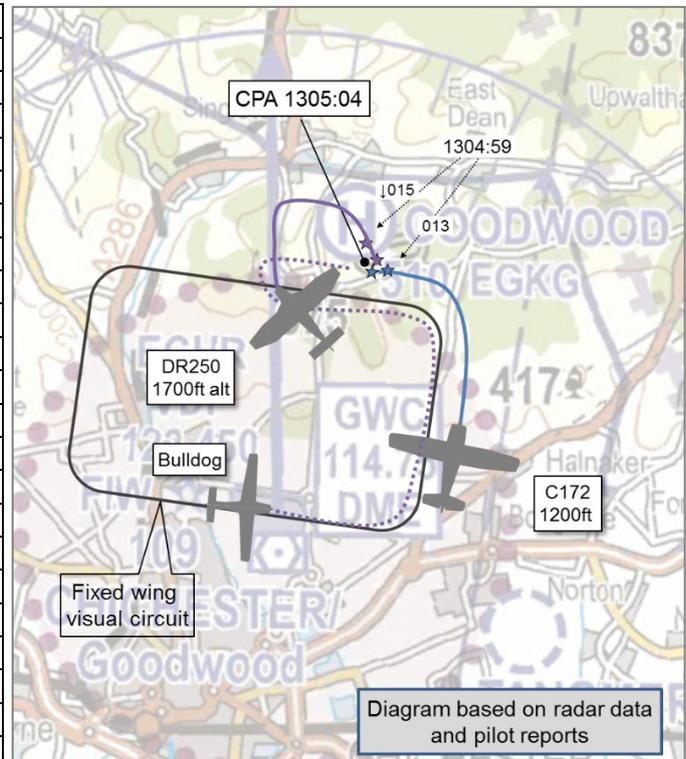
THE C172 INSTRUCTOR reports that whilst flying downwind for RW10 at Goodwood, a blue and white Robin appeared on the nose at the same altitude approximately 500m away. He banked the aircraft to the right and then another previously unseen aircraft passed close down the port side.

THE BULLDOG PILOT reports that he departed from RW10 and routed north of Goodwood racecourse; once clear of the ATZ he set course heading 080°. He then became visual with a Cessna in the opposite direction and approximately ½nm away. He performed a brief wing waggle to see whether they had seen him but, with no response, he made a turn to the right to pass south of the aircraft by about 200ft.

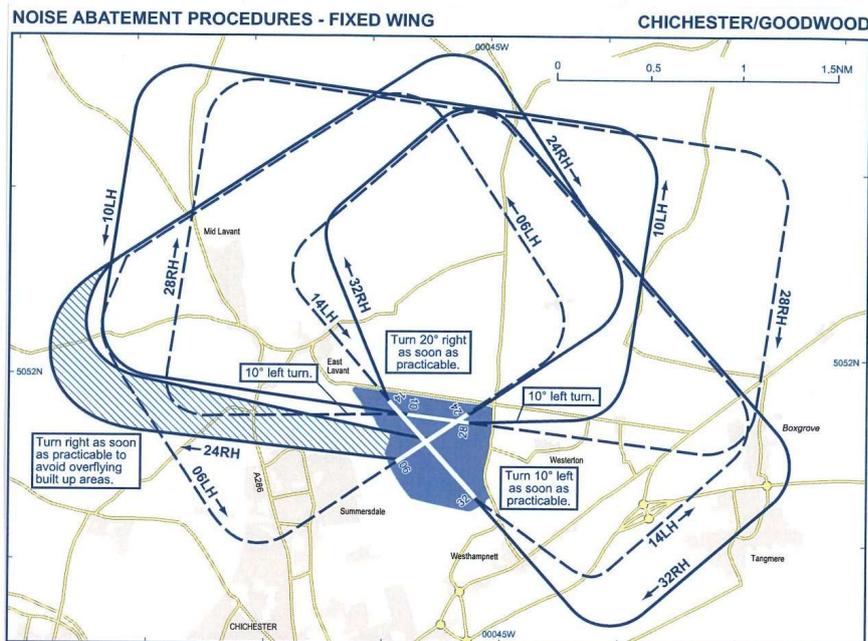
Figure 4 Chichester/Goodwood Fixed-Wing Noise Abatement Procedures.

The Chichester/Goodwood fixed-wing noise abatement circuit procedures are at Figure 4 (taken from their website). The RW10LH pattern is shown on the diagram at the beginning of this report.
