AIRPROX REPORT No 2019075

Date: 18 Apr 2019 Time: 1302Z Position: 5233N 00024W Location: Sibson – elev 130ft

PART A: SUMMARY OF INFORMATION REPORTED TO UKAB

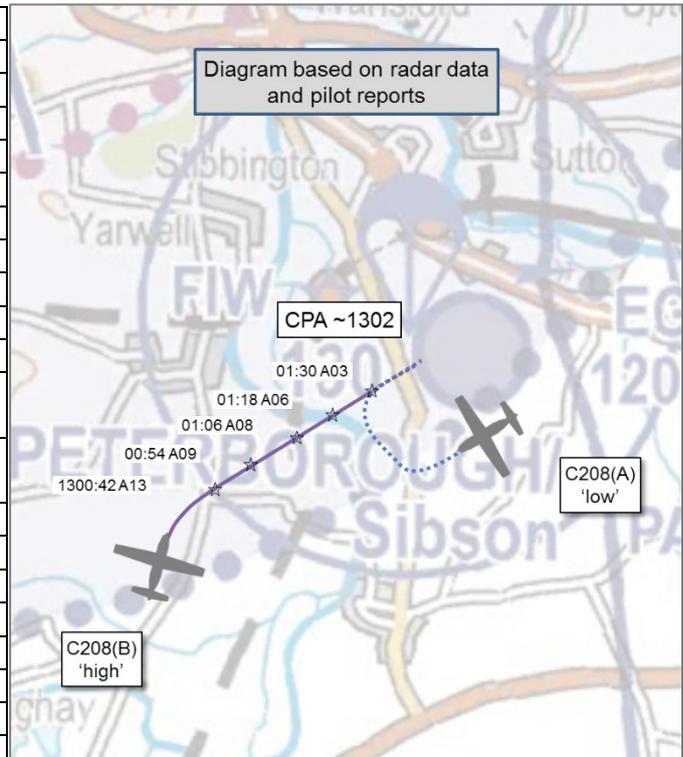
THE AGCS OPERATOR reports that the two C208s were operated by the same parachuting company, one parachute dropping and the other pilot training on the day. He noted that the locally based flying school operate flying training and the R/T from the Tower. The AGCS Operator stated that a separate take-off incident at the start of their sortie had caused them concern as to the standard of awareness of the 208(B) pilot. Five minutes later, C208(B) was on the descent and reported left-base and then long-final (but later agreed that it was short-final). The C208(A) also turned final and the situation was that one C208 was right on top of the other with both intent on landing. The AGCS Operator realised the situation and called the top aircraft (C208(B)) to go-around. Both pilots were unaware of the position of the other C208 and, if not told to go around, it was estimated that a collision would have occurred after about 5 seconds.
