AIRPROX REPORT No 2019106

Date: 14 May 2019 Time: 1555Z Position: 5050N 00015W Location: Brighton City Airport

PART A: SUMMARY OF INFORMATION REPORTED TO UKAB

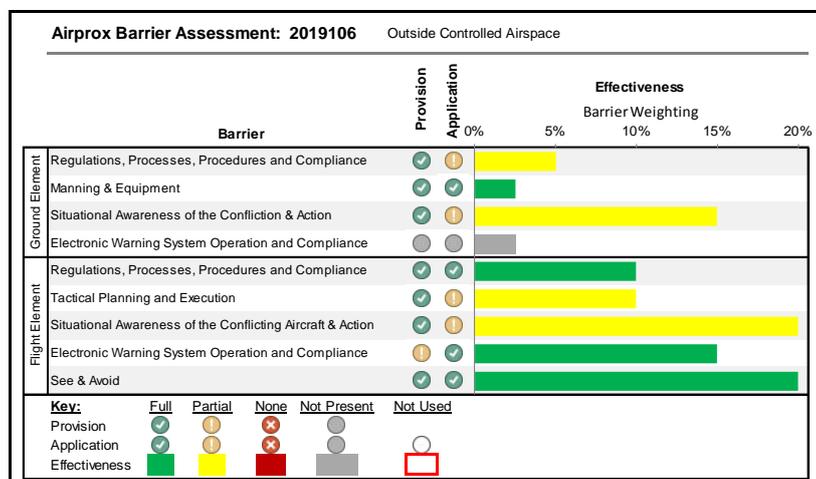
Regulations, Processes, Procedures and Compliance were assessed as **partially effective** because the controller passed inadequate Traffic Information to the PA28.

Tactical Planning and Execution was assessed as **partially effective** because the DA40 pilot did not modify his plan once he became aware of the PA28 getting airborne for a right turnout.

Situational Awareness of the Conflicting Aircraft and Action were assessed as **partially effective** because the DA40 pilot did not take positive action to integrate even though he knew the PA28 had turned towards him.
