AIRPROX REPORT No 2019137

Date: 04 Jun 2019 Time: 1707Z Position: 5200N 00124W Location: 10nm N Oxford Airport

PART A: SUMMARY OF INFORMATION REPORTED TO UKAB

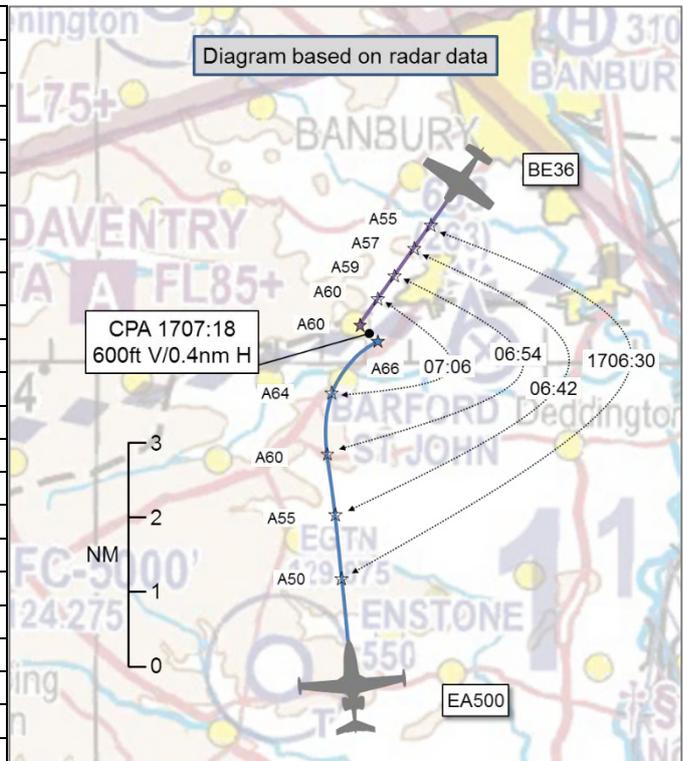
THE EA500 PILOT reports that he had been handed over to ‘London’ on departure and was cleared to climb to FL090 en-route IXURA under a Traffic Service [UKAB Note: actually only a Basic Service]. He saw the other traffic on TCAS at 10nm and was given Traffic Information by the ‘London controller’ at about 5nm. On changing the TCAS range display, it alerted so he disconnected the autopilot, stopped his climb, made a 90° hard-right turn and called ‘London’. He last saw the TCAS alert at ‘+500’ directly over his aircraft but did not see the other aircraft. The pilot stated that he was not looking to criticise the ‘London controller’, and that if the controller had not alerted him the outcome might have been different. He felt that it would be good to see whether this airspace could be operated differently.

The pilot assessed the risk of collision as ‘High’.

THE BE36 PILOT discussed the Airprox briefly with an Inspector and stated that he was operating under VFR and did not observe another aircraft in proximity. He declined to submit a completed form CA1094 Airprox report.
