AIRPROX REPORT No 2019139

Date: 09 Jun 2019 Time: 1033Z Position: 5213N 00002W Location: Overhead Bourn Airfield

PART A: SUMMARY OF INFORMATION REPORTED TO UKAB

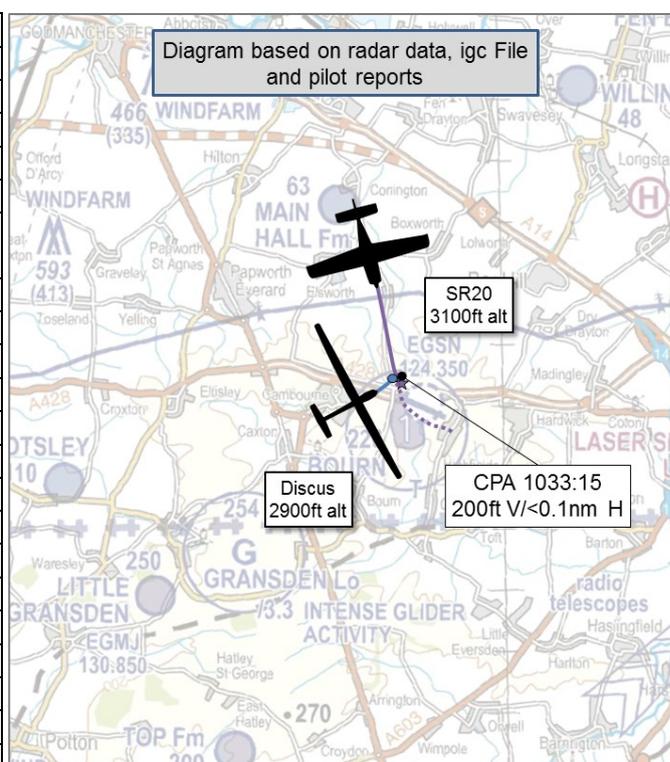
THE DISCUS GLIDER PILOT reports that he was manoeuvring to re-position into the best lift in a thermal. The SR20 passed down his port side from behind and crossed his nose as his turn progressed. He attempted to stop the turn, but this was not effective due to the slow roll rate of his aircraft. The SR20 was not seen until he appeared from behind his port wing at high relative speed and at what he would have said was already the closest proximity. The SR20 continued in a straight-and-level flight as though the SR20 pilot hadn't seen him. Although he was Listening Out on Cambridge Approach he did not have any indication of the presence of the SR20. He is aware that Cambridge ATC is closed at weekends so there is no Basic Service available.
