AIRPROX REPORT No 2019157

Date: 22 Jun 2019 Time: ~0952Z Position: 5143N 00205W Location: ~2nm NE Aston Down

PART A: SUMMARY OF INFORMATION REPORTED TO UKAB

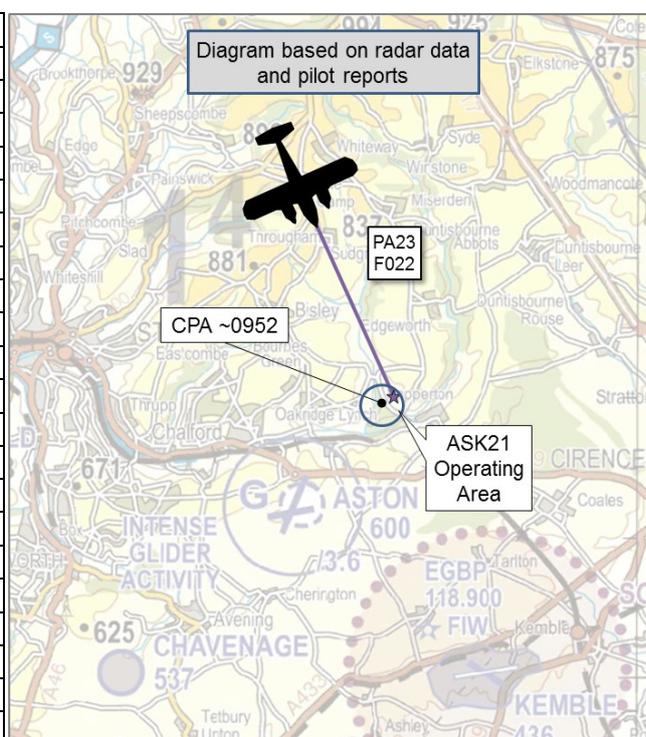
THE ASK21 PILOT reports giving an instructional flight, circling to the left, when the student called out that there was an aeroplane heading towards them from the NW. He saw the aeroplane as they came around the turn at ½ - 1nm, so he took control and made a sharp, well-banked turn to the right to avoid it as it flew by to their left. He could see the registration letters on the fuselage but couldn't make them out at the distance and speed of the aeroplane. It continued to fly in a straight-line heading SE towards Kemble airfield and did not appear to take any avoiding action, suggesting that it hadn't seen them.

A primary radar return is seen in the area of the Airprox for one radar sweep.

They reviewed the information available and tried to see if they could reconstruct any flight paths. The PA23 carries mode S, and so is able to be seen on FlightRadar24 (FR24). However, due to the limitations of MLAT at lower levels, the track of the flight is not complete and ends approximately 1 min before the event. At 0950z, the position of the PA23 is recorded as tracking directly towards Aston Down on a southerly heading. They have assumed that the other aircraft involved in the event originated from the local Gliding Club, but this is just an assumption. No glider shows on FR24. They do not know if the gliders are equipped with FLARM or PowerFLARM, or whether, if so, the system was switched on. They are aware from talks given at regional airspace user groups that conspicuity systems are not always switched on in gliders in order to preserve battery life or even to disguise their position, either good thermals or during competitions. PowerFLARM detects Mode S transmissions, so would have made the PA23 visible to the glider. They have spoken to the pilot of the PA23. He was in communication with Bristol Radar during that section of the flight but does not know if he had contacted Bristol at the time of the reported event. He does not recall any traffic information being given regarding the presence of the glider, and states that Bristol just asked him to report leaving. The PA23 pilot has spoken to the task specialist, who was on the aircraft, and he has no recollection of any traffic information being passed.
