**AIRPROX REPORT No 2019178**

Date: 03 Jul 2019 Time: ~1045Z Position: 4954N 00617W Location: 5nm NE St Mary's

**PART A: SUMMARY OF INFORMATION REPORTED TO UKAB**

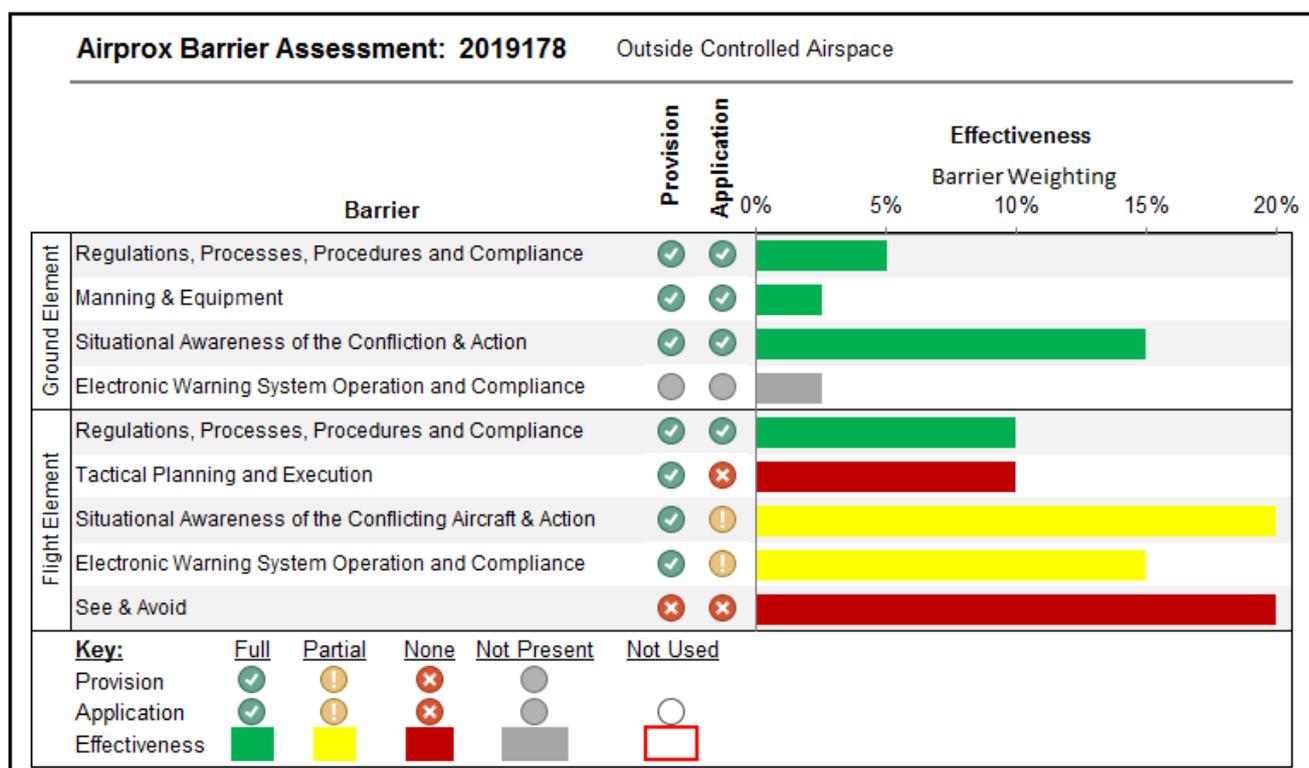
**Electronic Warning System Operation and Compliance** were assessed as **partially effective** because the EC135 pilot's TCAS did not appear to have alerted as expected.

**See and Avoid** were assessed as **ineffective** because the EC135 pilot did not see the opposite direction DHC6 and the DHC6 pilot only saw the EC135 at CPA.
