AIRPROX REPORT No 2019179

Date: 05 Jul 2019 Time: 1153Z Position: 5048N 00015W Location: W Seaford

PART A: SUMMARY OF INFORMATION REPORTED TO UKAB

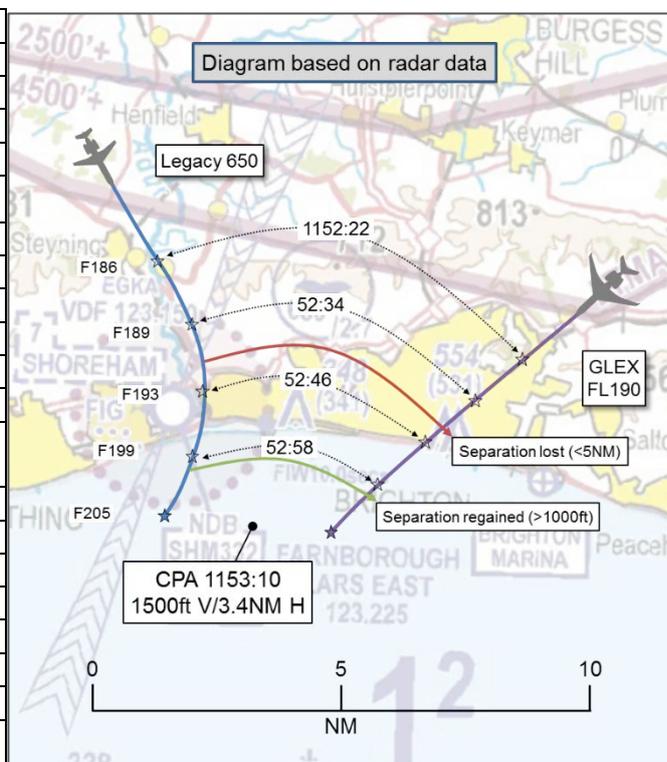
Recorded	Aircraft 1	Aircraft 2
Aircraft	Legacy	Global Express
Operator	Civ Comm	Civ Comm
Airspace	London FIR	London FIR
Class	A	A
Rules	IFR	IFR
Service	Radar Control	Radar Control
Provider	Swanwick	Swanwick
Altitude/FL	FL197	FL190
Transponder	A,C,S	A,C,S
Reported		
Colours	Mainly white	White
Lighting	Strobe, red beacon, nav	Strobe, landing, nav
Conditions	VMC	IMC
Visibility	>10km	NK
Altitude/FL	FL190	FL140
Heading	NK	215°
Speed	300kt	250kt
ACAS/TAS	TCAS II	TCAS II
Alert	TA	TA
Separation		
Reported	500ft V/4-5nm H (on TCAS)	Not seen
Recorded	700ft V/4.2nm H 1500ft V/3.4nm H
