## AIRPROX REPORT No 2019206

Date: 24 Jul 2019 Time: 1118Z Position: 5315N 00058W Location: Retford/Gamston Aerodrome

### PART A: SUMMARY OF INFORMATION REPORTED TO UKAB

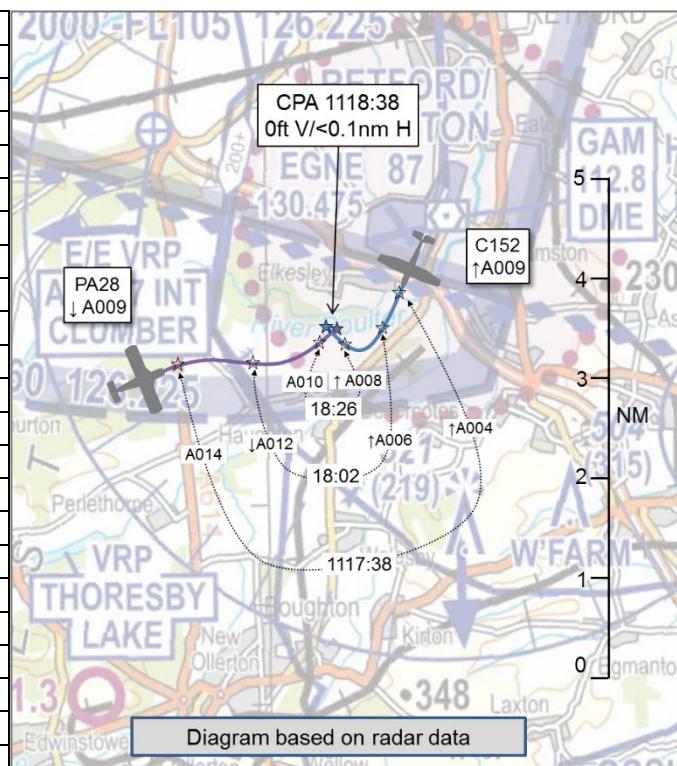
**THE C152 PILOT** reports that he was flying as the instructor with a student in the circuit and that the student was in control at the time. As they approached level-off height right-crosswind for RW21RH, they prepared to turn downwind. They both looked left and the student saw the other aircraft very close (the instructor could not see the other aircraft due to the student and port-side door); he immediately pitched up. The instructor only saw the other aircraft as it appeared out of the starboard window after passing below his aircraft. The instructor subsequently established contact with the pilot of the PA28 to inform him that he considered that the PA28 pilot had cut into an active circuit in close proximity to the Cessna.
