AIRPROX REPORT No 2019209

Date: 26 Jul 2019 Time: 1612Z Position: 5332N 00240W Location: 1nm E MIRSI

PART A: SUMMARY OF INFORMATION REPORTED TO UKAB

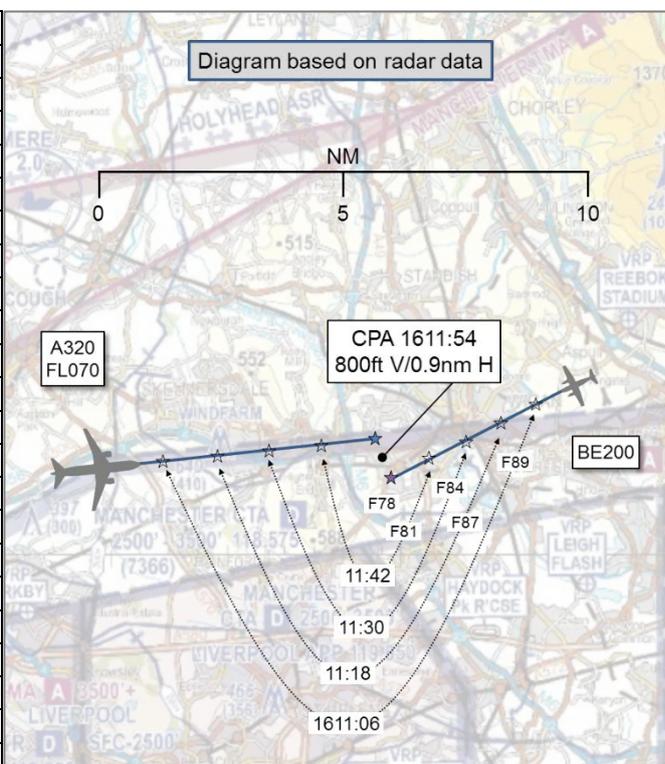
Recorded	Aircraft 1	Aircraft 2
Aircraft	A320	BE200
Operator	CAT	Civ Comm
Airspace	Manchester TMA	Manchester TMA
Class	A	A
Rules	IFR	IFR
Service	Radar Control	Radar Control
Provider	Manchester APP	Wallasey Sector
Altitude/FL	FL70	FL78
Transponder	A,C,S	A,C,S ¹
Reported		
Colours	Company	NK
Lighting	NK	NK
Conditions	VMC	NK
Visibility	10km	NK
Altitude/FL	FL70	FL80
Heading	NK	NK
Speed	250kt	NK
ACAS/TAS	TCAS II	TAS
Alert	None	None
Separation		
Reported	NK	Not seen
Recorded	800ft V/0.9nm H

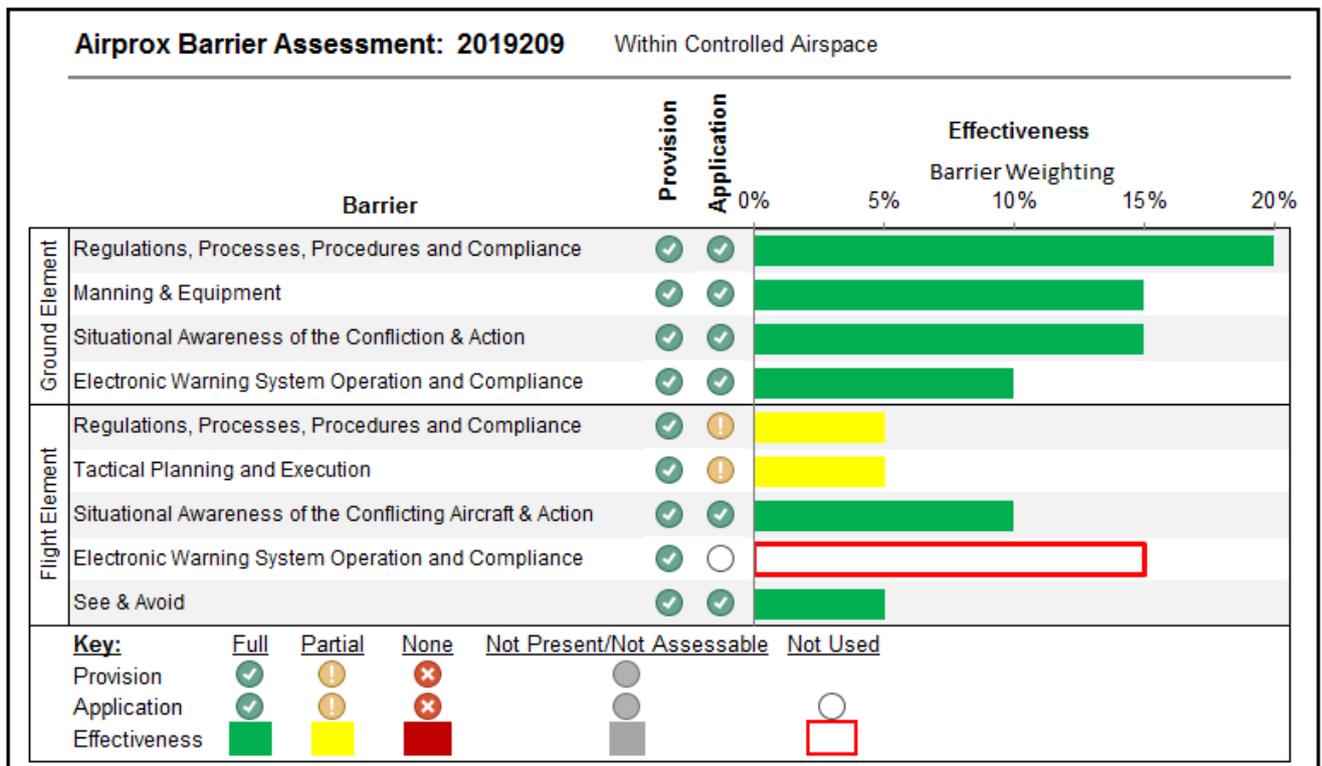
Tactical Planning and Execution was assessed as **partially effective** because although the BE200 descended through its cleared level, the pilot quickly realised the situation and climbed back to the required level.
