AIRPROX REPORT No 2019279

Date: 19 Sep 2019 Time: 1133Z Position: 5153N 00209W Location: Gloucestershire Airport

PART A: SUMMARY OF INFORMATION REPORTED TO UKAB

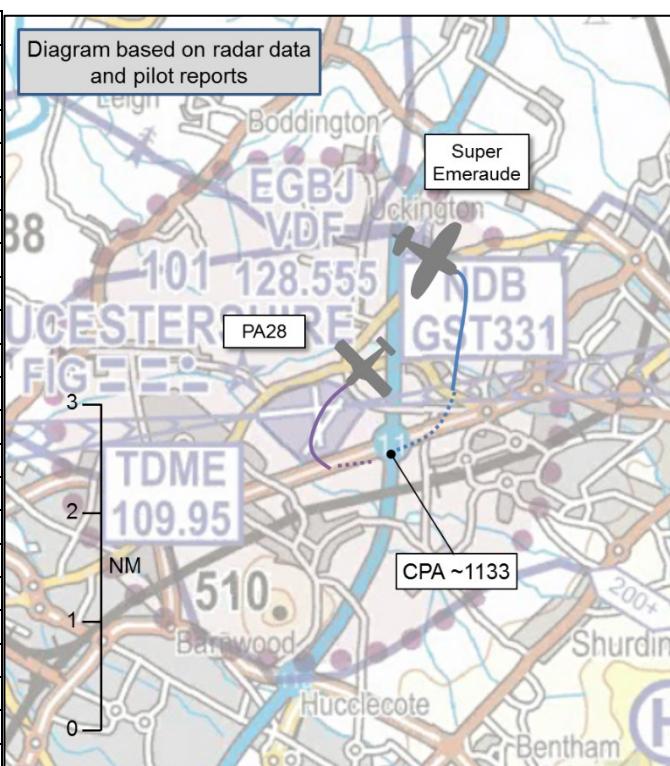
THE PIEL SUPER EMERAUDE (CP32) PILOT reports that he was joining at Gloucestershire for an overhead join for RW27RH at 2300ft. He was told by ATC that another aircraft was joining and he saw an aircraft tracking left-to-right and reported visual. However, after reporting ready to descend deadside and receiving a clearance from ATC, it became apparent that there was another aircraft in their 2 o'clock, slightly below, coming towards them. He reported to ATC that he had an aircraft turning towards them in a left-hand pattern in the overhead. Due to the close proximity of the other aircraft, he reduced his rate of descent and stopped the right-hand turn to continue straight ahead. Once the other aircraft was clear he continued with the deadside descent. ATC reported that they could not see the other aircraft and once he had stated its position again, they asked the other pilot to climb in a right turn back into the overhead and await further instructions. Once on the ground it became obvious that the other pilot had turned left instead of right in the overhead and descended on the wrong side.

THE PA28 PILOT reports that he contacted Gloster App to report inbound from the northeast. He was told to join overhead and descend deadside for RW27RH. He joined in the overhead to descend deadside, but made a left-hand turn to get into position. This was reported to ATC by another pilot. On completing crosswind he called downwind and was told by ATC to return to the overhead, he then returned to the overhead from late downwind RW27, which is when he assumed the Airprox took place.

The Board quickly agreed that this incident had occurred because the PA28 pilot had turned left instead of right when joining in the Gloucester overhead. Members noted that the Gloucester AIP entry instructed right-hand turns (**CF3, CF4**) and that the App controller had also advised that it was a right-hand circuit (**CF5**). A member commented that pilots can sometimes get confused about turn directions when approaching an overhead join, and that a good way of avoiding this was to always keep the airfield on the specified side of the circuit direction. So, in this case, a right-hand pattern means always keep the airfield on the right. By doing that, it is then natural to turn in the right direction when conducting the join. Ultimately, in not following the correct joining procedure, members agreed that the PA28 pilot had not conformed to the pattern of traffic formed by the other aircraft in the circuit, about which he had been given Traffic Information (**CF6, CF7**).
