AIRPROX REPORT No 2019297

Date: 17 Oct 2019 Time: 1442Z Position: 5328N 00146W Location: Derwent Valley

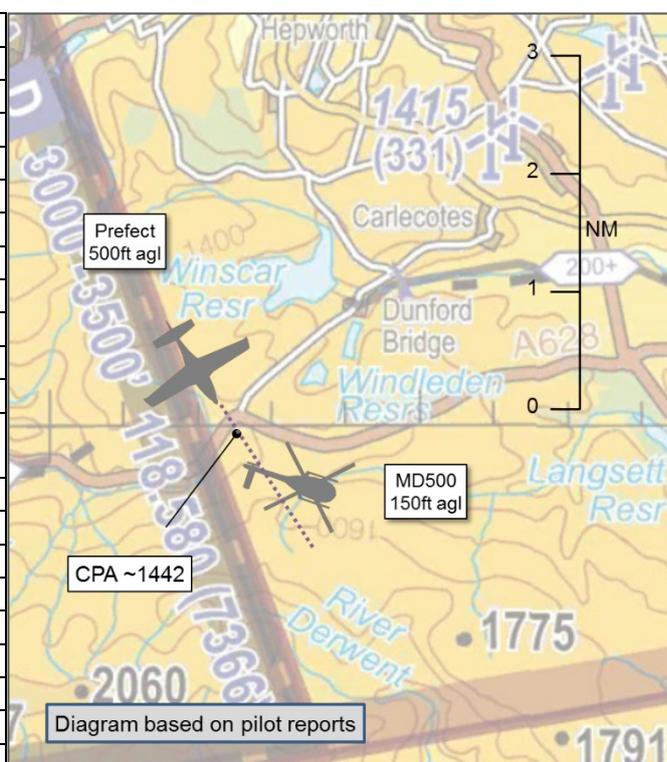
THE MD500 PILOT reports that he was conducting HESLO [underslung load-lifting] operations within a NOTAM'd ops area and had limited radio contact with ATC due to distance & operating altitude. He had been there for about 1.5hrs when a fixed-wing aircraft flew through but disappeared very quickly and he believed it to be a one-off incident. However, approximately 2hrs later, the same aircraft type did exactly the same thing, same location, same phase of helicopter flight, followed 10 mins later by a third occurrence again the same fixed-wing type, this one took late & significant avoiding action to box around the helicopter, before resuming track, low-level, down the Derwent Valley. The groundcrew were the first to catch sight of the aircraft and gave an immediate radio call to the pilot, but it was too late to take any action and he was unable to manoeuvre with any degree with the underslung load because he was already at maximum take-off power. The second & third incidents were reported to Manchester ATC by radio (pilot flying) and by telephone (groundcrew). Operations continued at first because they could do no more to remedy the situation. However, shortly after the third occurrence by identical aircraft within a 2hr period, HESLO ops were suspended. He noted that he was operating with a 'longline', somewhere between 50-100ft making them a bigger target; they normally have a cycle time of between 3 and 5mins between loads and keep flying from first-light to last-light. He opined that the Chinook crews normally gave them a phonecall if they were in the area and he normally passed them a discreet frequency to call up on. He considered the second aircraft the closest and it was so close he instinctively ducked as it flew overhead.

The pilot assessed the risk of collision as 'High'.
