AIRPROX REPORT No 2019313

Date: 13 Nov 2019 Time: 1159Z Position: 5159N 00222W Location: 1nm west of Berrow

PART A: SUMMARY OF INFORMATION REPORTED TO UKAB

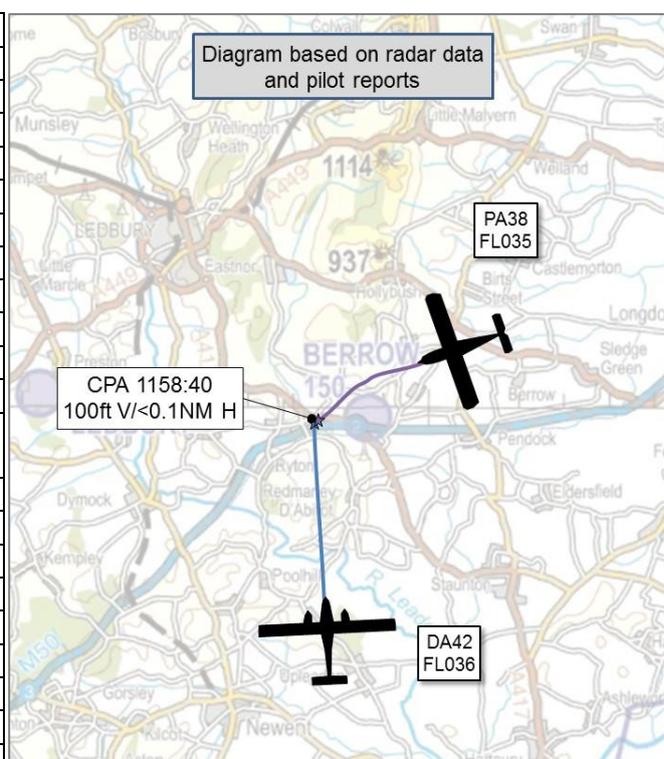
Recorded	Aircraft 1	Aircraft 2
Aircraft	DA42	PA38
Operator	Civ FW	Civ FW
Airspace	London FIR	London FIR
Class	G	G
Rules	VFR	VFR
Service	Basic	Basic
Provider	Gloster	Gloster
Altitude/FL	FL036	FL035
Transponder	A, C, S	A, C
Reported		
Colours	White	White, Blue
Lighting	Landing, Strobe, Position	Strobe
Conditions	VMC	VMC
Visibility	>10km	10km
Altitude/FL	3000ft	2000ft
Altimeter	QNH (999hPa)	QNH
Heading	360°	Not reported
Speed	125kt	90kt
ACAS/TAS	TAS	Not fitted
Alert	TA	N/A
Separation		
Reported	20-30ft V/50m H	Not seen
Recorded	100ft V/<0.1NM H
