AIRPROX REPORT No 2019036

Date: 25 Feb 2019 Time: 1413Z Position: 5044N 00208W Location: 11nm WSW Bournemouth

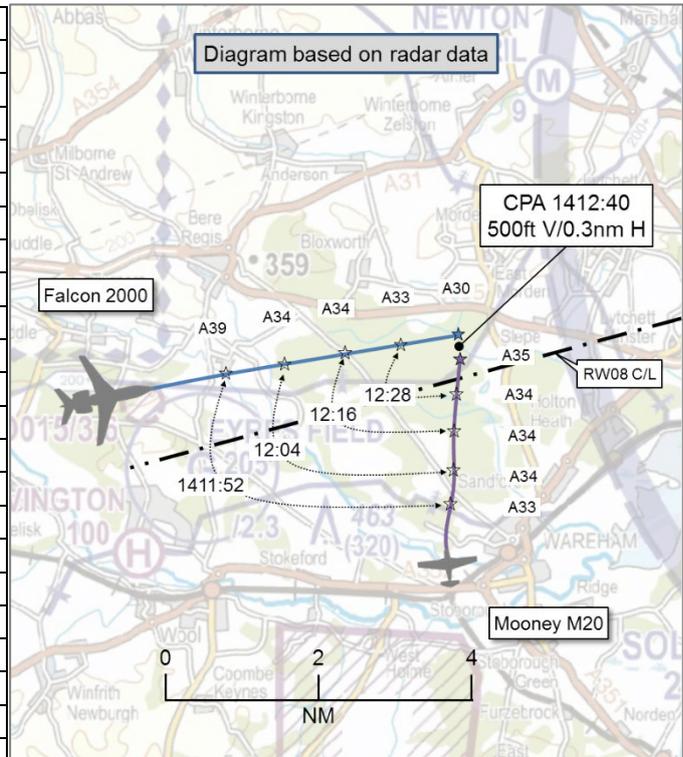
Recorded	Aircraft 1	Aircraft 2
Aircraft	Falcon 2000	Mooney M20
Operator	Civ FW	Civ FW
Airspace	London FIR	London FIR
Class	G	G
Rules	IFR	VFR
Service	Traffic	Listening Out
Provider	Bournemouth	Solent Radar
Altitude/FL	3600ft	4100ft
Transponder	A, C, S	A, C, S
Reported		
Colours	White, gold	Grey
Lighting	Strobe, nav	NK
Conditions	VMC	VMC
Visibility	>10km	'CAVOK'
Altitude/FL	4000ft	4000ft
Altimeter	NK (1033hPa)	QNH (1035hPa)
Heading	075°	NK
Speed	240kt	145kt
ACAS/TAS	TCAS II	TAS
Alert	RA	'Alert'
Separation		
Reported	'slightly above' V NK H	500ft V/0m H
Recorded	500ft V/0.3nm H

THE FALCON PILOT reports that they were descending towards the BIA NDB when the controller warned of traffic closing from the right, which was confirmed on TCAS. The controller called the other traffic and warned it of 'Jet in 11 o'clock left/right' but had no response. The Falcon pilot monitored the closing traffic; the controller continued to warn him of its proximity and cleared them to continue descent to 2500ft to alleviate the problem. Whilst resetting for further descent, a TCAS RA occurred which was followed until clear of conflict. The other traffic was seen close in by the Training Captain (RHS) whilst the RA descent was in progress. An Airprox was called by the Training Captain, followed by a follow up call to ATC when on the ground.
