AIRPROX REPORT No 2019049

Date: 28 Mar 2019 Time: 1001Z Position: 5127N 00338W Location: Ogmore by Sea

PART A: SUMMARY OF INFORMATION REPORTED TO UKAB

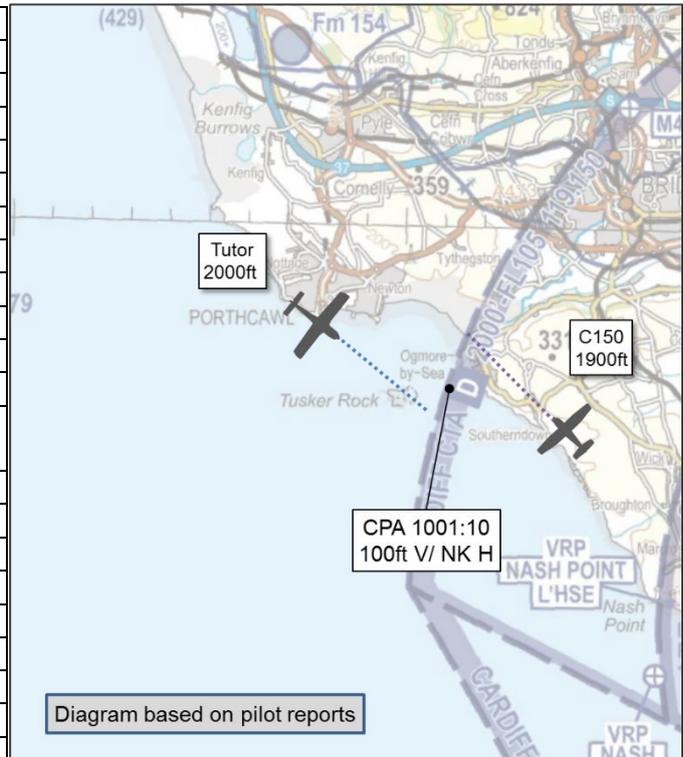
Recorded	Aircraft 1	Aircraft 2
Aircraft	Tutor	C150
Operator	HQ Air (Trg)	Civ FW
Airspace	London FIR	London FIR
Class	G	G
Rules	VFR	VFR
Service	Basic	Basic
Provider	Cardiff	Cardiff
Altitude/FL		
Transponder	A, C, S	A, C
Reported		
Colours	White	Red
Lighting	HISL, Landing, Nav	Beacon, Landing
Conditions	VMC	VMC
Visibility	10km	10km
Altitude/FL	2000ft	1200ft
Altimeter	QNH (1037hPa)	QNH
Heading	090°	NK
Speed	120kt	80kt
ACAS/TAS	TAS	Not fitted
Alert	Information	N/A
Separation		
Reported	100ft V/500m H (seen on TAS)	10ft V/0.75nm H
Recorded	100ft V/ 1.3nm H
