AIRPROX REPORT No 2019053

Date: 03 Apr 2019 Time: 1532Z Position: 5310N 00019W Location: 7nm NW Coningsby

PART A: SUMMARY OF INFORMATION REPORTED TO UKAB

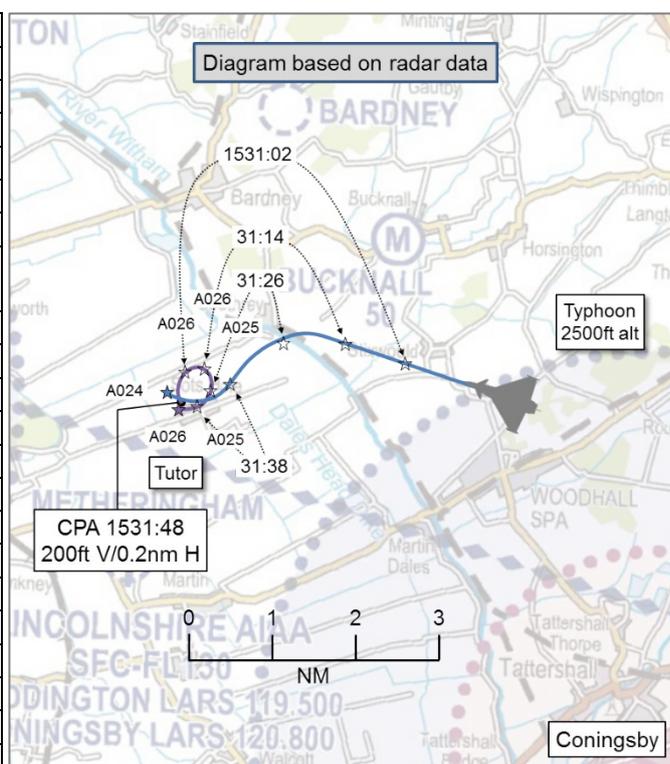
THE TYPHOON PILOT reports that he was in the instrument pattern for a radar-to-PAR. He requested a Deconfliction Service, but was asked if a Traffic Service was possible because aircraft were holding off from Cranwell due to poor weather. He accepted a Traffic Service as the conditions were mostly VMC. The pilot of the Typhoon behind him in the instrument pattern called traffic on his radar at '9 miles converging, co-altitude'. This traffic (which was not involved in the Airprox but increased the R/T) was assessed as approximately right 9 o'clock from the [Airprox] Typhoon. At about 1531:40, the Typhoon pilot saw a light-aircraft (identified as either a Tutor or a Prefect) in the left 10 o'clock already on a diverging course. The light-aircraft was in a left-turn away, but didn't appear to be 'breaking away'.

THE TUTOR PILOT reports that he was conducting a Medium-Level Navex sortie, which involved routing anti-clockwise around the Coningsby MATZ at 2000ft on the RPS, due to cloud, with a Traffic Service from Coningsby LARS on VHF. Whilst he was routing south for the Cranwell/Coningsby MATZ Gap, he was asked by Coningsby ATC if he was able to either climb or descend from 2000ft for Typhoon traffic recovering for Coningsby RW07. He was unable to do so due to the weather conditions at the time (whilst maintaining VMC) so agreed to maintain a position just south of Bardney village (about 8nm NW of Coningsby) at 2000ft as the Typhoons were recovered. Whilst in an orbit at this position he received TI on one Typhoon, which he briefly saw but with no conflict. A short time later, he received further TI on another Typhoon in the radar pattern at a similar level. Whilst trying to gain visual contact on the Typhoon using the aircraft's TAS, he first received a Proximity Advisory (<5nm, <+/- 1200ft) and then a Traffic Advisory (<0.55nm, <+/- 800ft). A very short time later, he saw the Typhoon and commenced a steeper turn to move away. He saw the Typhoon bank away at the same time.

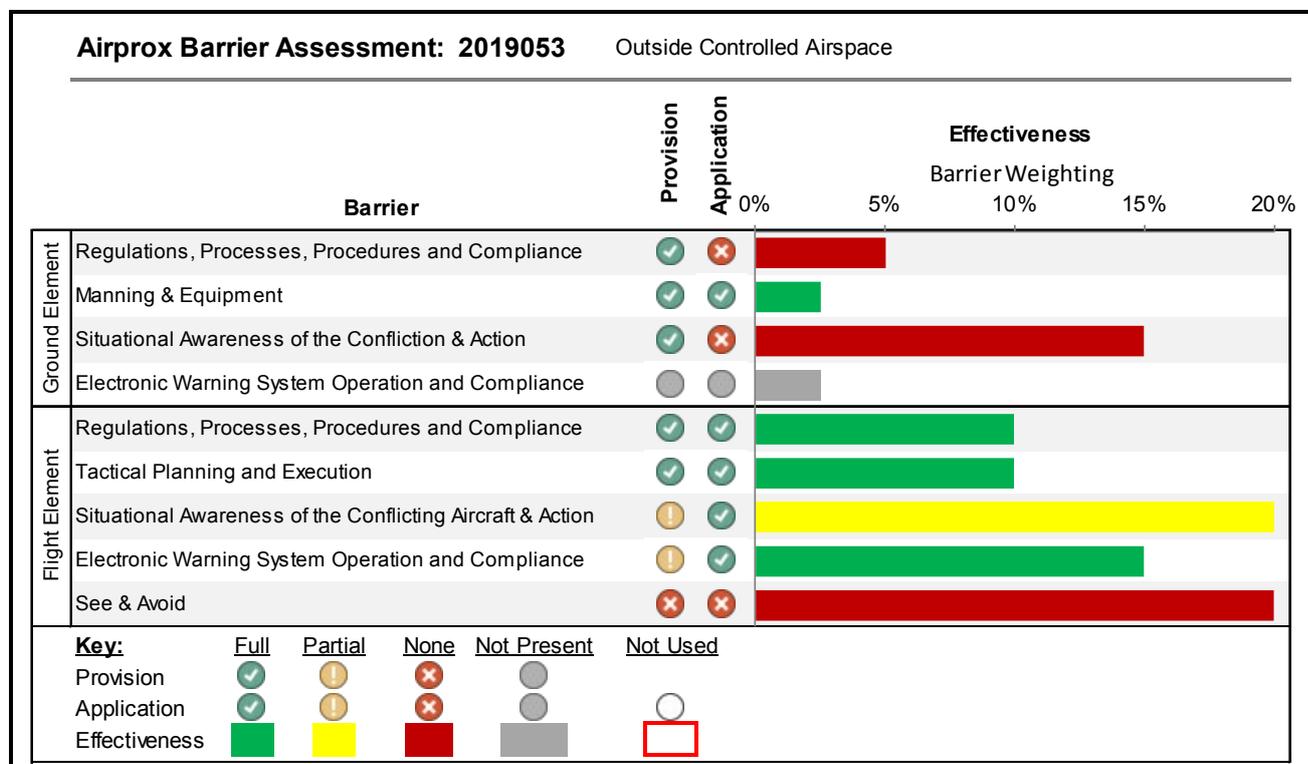
Situational Awareness of the Conflicting Aircraft and Action were assessed as **partially effective** because the Typhoon pilot did not receive Traffic Information until at a range of 2.7nm from the Tutor.

See and Avoid were assessed as **ineffective** because neither pilot saw the other aircraft before CPA, effectively a non-sighting, and consequently neither were able to manoeuvre to increase separation at CPA.
