AIRPROX REPORT No 2019078

Date: 21 Apr 2019 Time: 1646Z Position: 5053N 00125W Location: 4nm SW SAM VOR

PART A: SUMMARY OF INFORMATION REPORTED TO UKAB

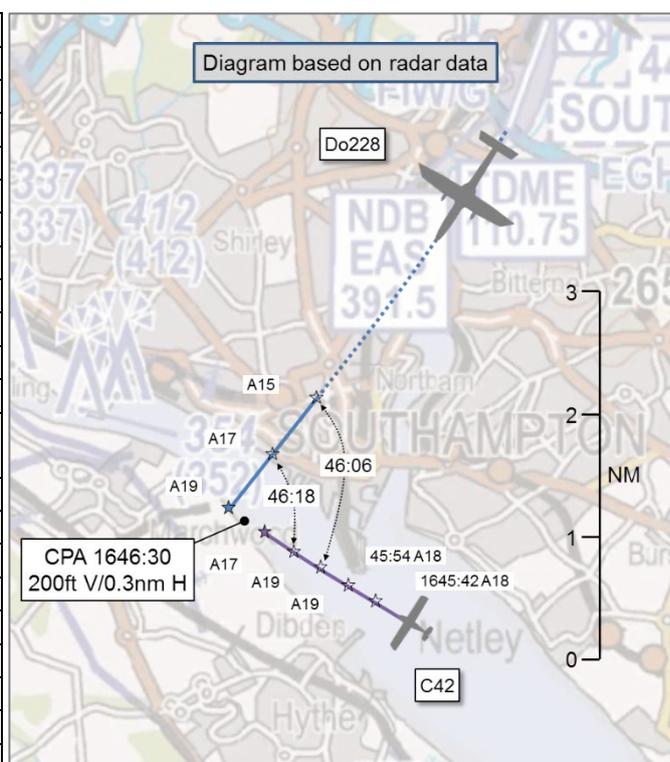
Recorded	Aircraft 1	Aircraft 2
Aircraft	Do228	C42
Operator	CAT	Civ FW
Airspace	CTR	CTR
Class	D	D
Rules	IFR	VFR
Service	Radar Control	Radar Control
Provider	Solent	Solent
Altitude/FL	FL18	FL16
Transponder	A,C,S	A,C,S
Reported		
Colours	Company	NK
Lighting	Anti-col, nav strobes	NK
Conditions	VMC	VMC
Visibility		20km
Altitude/FL	1850ft	1700ft
Altimeter	QNH	QNH
Heading	217°	310°
Speed	154kt	80kt
ACAS/TAS	TCAS II	Not fitted
Alert	RA	N/A
Separation		
Reported	50ft V/0.1nm H	200ft V/1km H
Recorded	200ft V/0.3nm H
