**AIRPROX REPORT No 2019110**

Date: 19 May 2019 Time: 1503Z Position: 5210N 00004W Location: Gransden Lodge

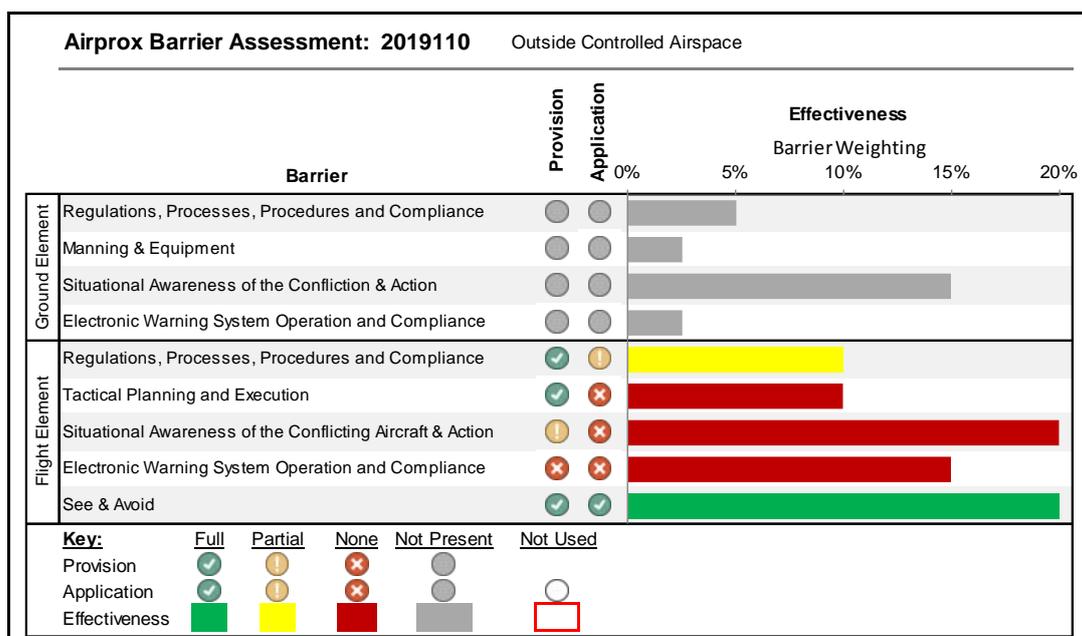
**Situational Awareness of the Conflicting Aircraft and Action** were assessed as **ineffective** because the Mustang and Sea Fury pilots should have at least known generically that gliding took place at Gransden Lodge but they didn't take that into consideration when flying overhead at 1400ft.

**Electronic Warning System Operation and Compliance** were assessed as **ineffective** because although the DR400 was fitted with a FLARM, the Mustang wasn't FLARM equipped.
