AIRPROX REPORT No 2019111

Date: 21 May 2019 Time: 1619Z Position: 5043N 00209W Location: 2nm ENE Eyres Field

PART A: SUMMARY OF INFORMATION REPORTED TO UKAB

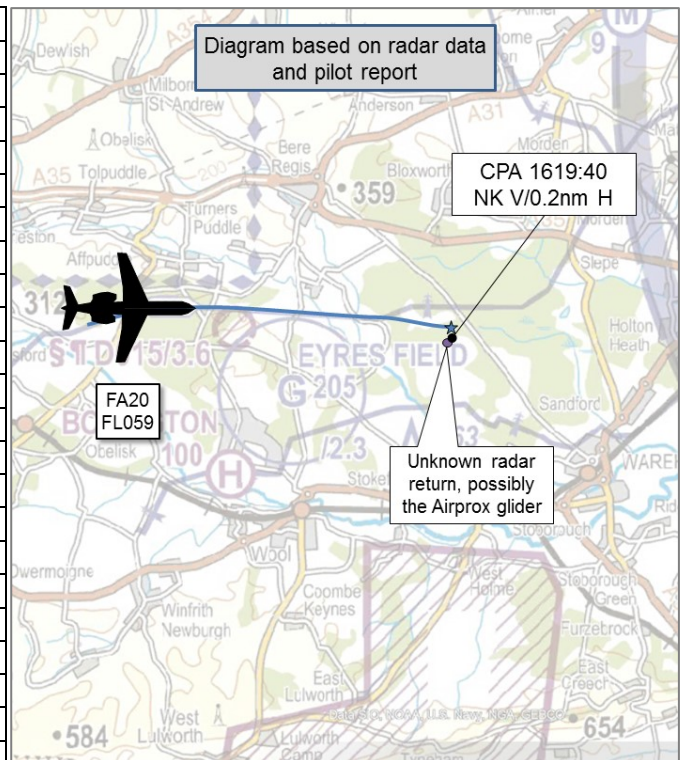
THE FA20 PILOT reports that he was under radar vectors for the ILS RW26 at Bournemouth and in the descent through 6000ft. They spotted the glider in their 1 o'clock at the same altitude with approximately 1500ft horizontal separation. The sighting was called between crew, and avoiding action was taken away from the glider via a left turn with continuing descent. The glider appeared to be heading west-north-west and straight-and-level. The glider was then seen turning left through the west. Bournemouth radar was informed of the avoiding action and, once clear of the conflict, radar vectors resumed. The glider was not in communication with Bournemouth nor seen on the Bournemouth radar.

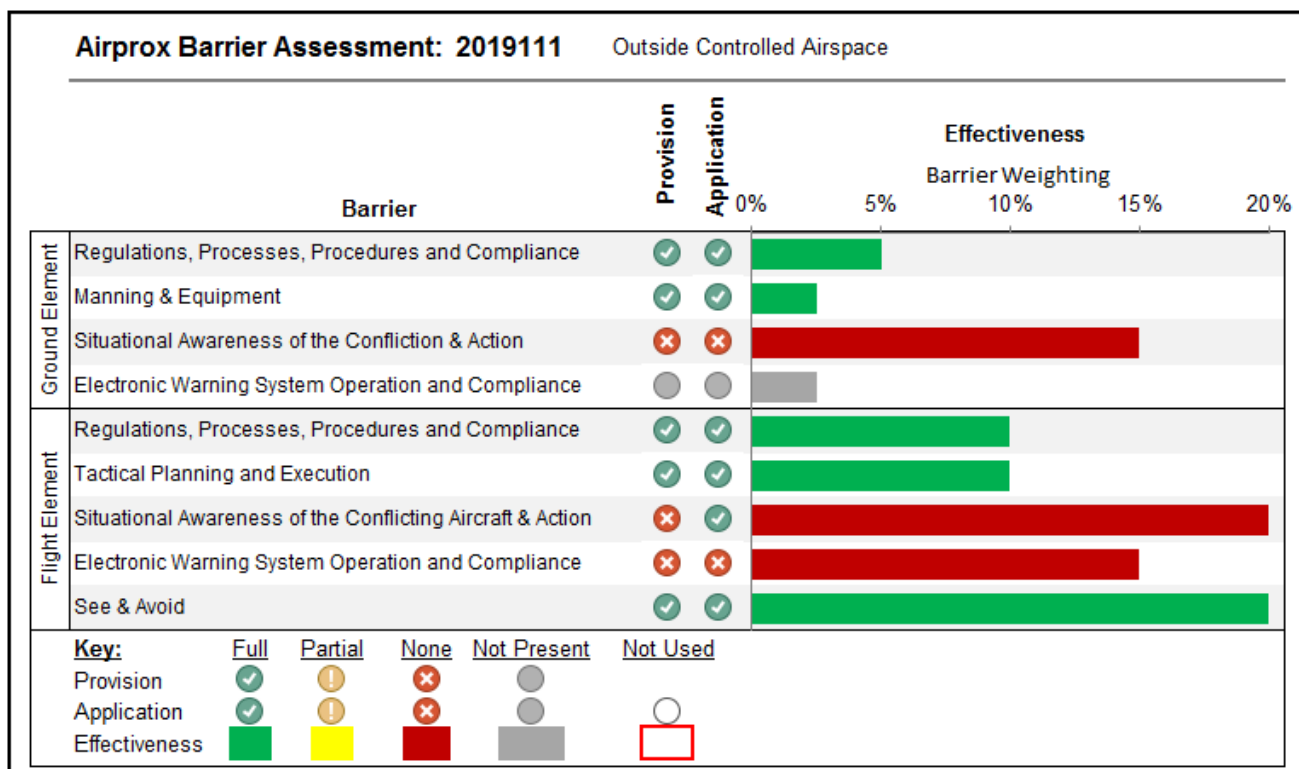
Situational Awareness of the Conflicting Aircraft and Action were assessed as **ineffective** because the FA20 pilot had no situational awareness of the glider, and it was assumed that the glider pilot was equally unaware of the FA20.

Electronic Warning System Operation and Compliance were assessed as **ineffective** because the FA20's TCAS II could not detect the non-transponding glider.
